IMPLEMENTATION OF THE MODEL SAFE SCHOOL PROGRAMME IN THE CARIBBEAN

HAZARD RISK ASSESSMENT REPORT AND COSTED ACTION PLAN

THE ADELE SCHOOL FOR SPECIAL CHILDREN

ANTIGUA AND BARBUDA

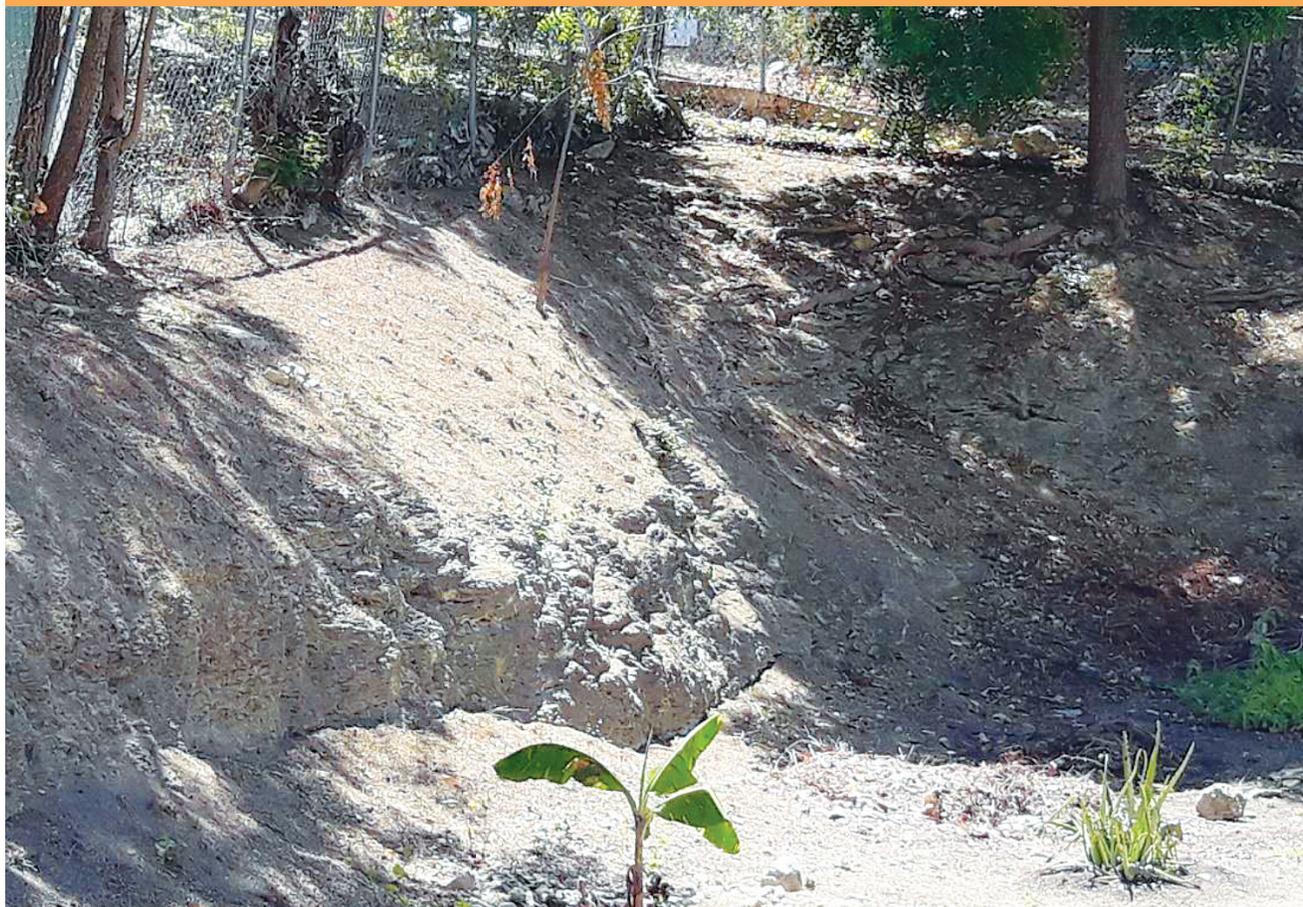
This school can be described as only marginally exposed to the landslide hazard as a result of the adjacent excavated earthen embankments (See Figure 4.1).

FIGURE 4.1: ADJACENT EXCAVATED EARTHEN EMBANKMENTS (POTENTIAL LANDSLIDE HAZARD)

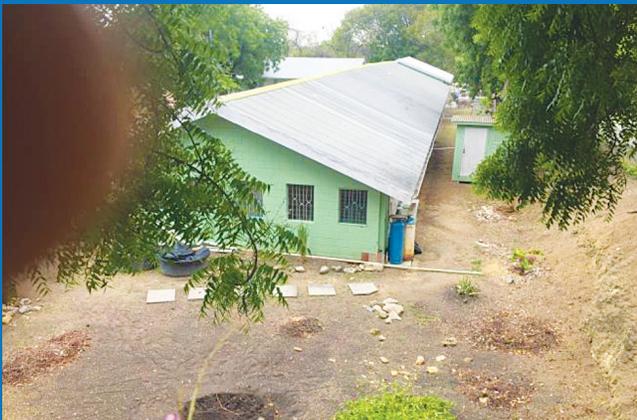
The Adele School for Special Children was assessed against its National Building Code which is common for the Organisation of Eastern Caribbean States (OECS) territory. The most serious area of deficiency was the Aluzinc roof covering on some of the buildings which appeared to lack the appropriate metal flashing especially at the gable ends. The main roof structures were found to be in generally good condition.

■ ALUZINC SHEETS ROOF COVERING

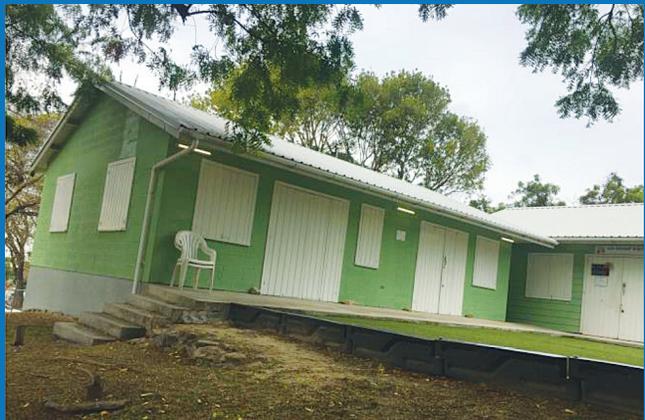
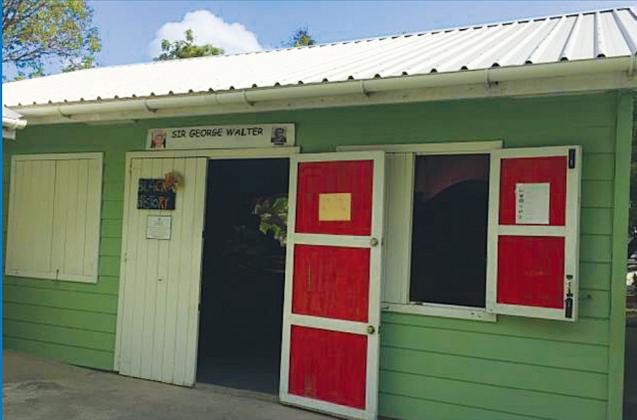
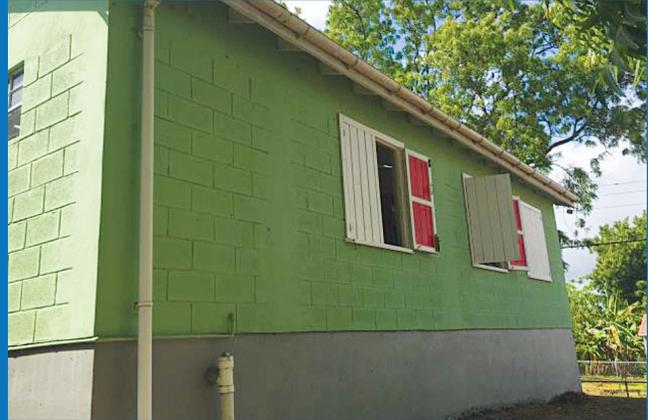
■ DETACHED TIMBER BUILDINGS WITH LIGHTWEIGHT ROOF

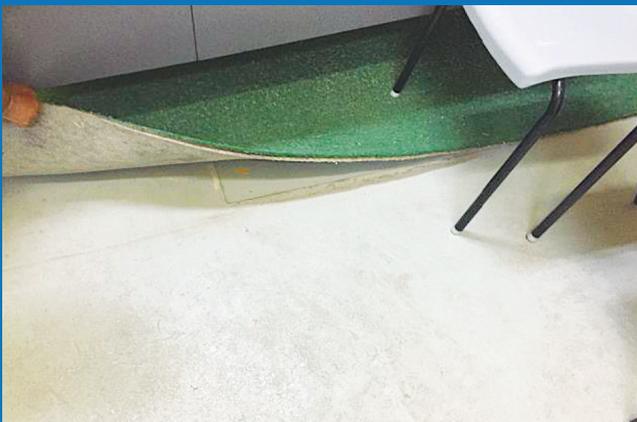
■ ADMINISTRATIVE OFFICE ON TOP OF WATER CISTERN MANHOLE COVER LOCATED BELOW DESK

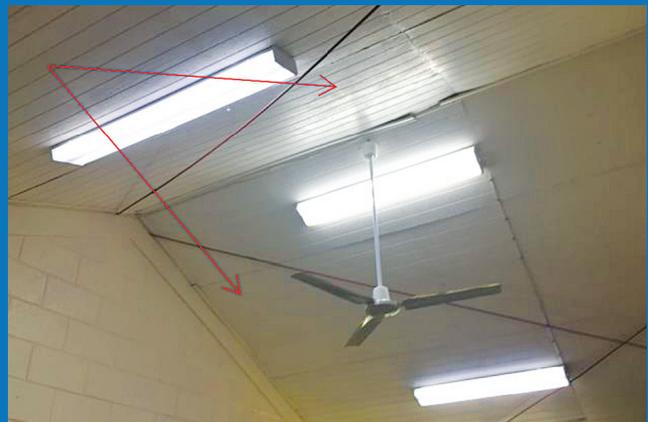
■ DIAGONAL BRACING TO STRUCTURAL STEEL ROOF STRUCTURE

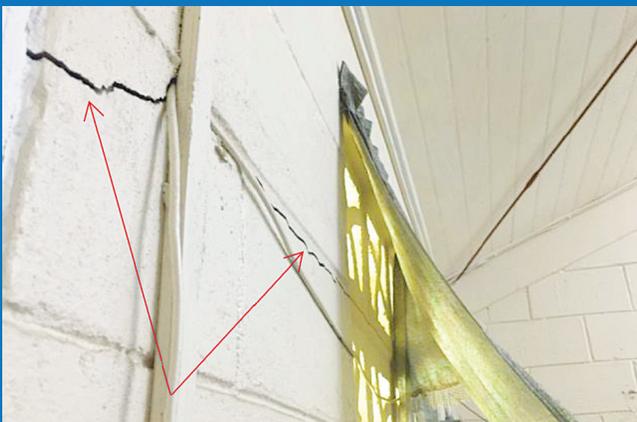
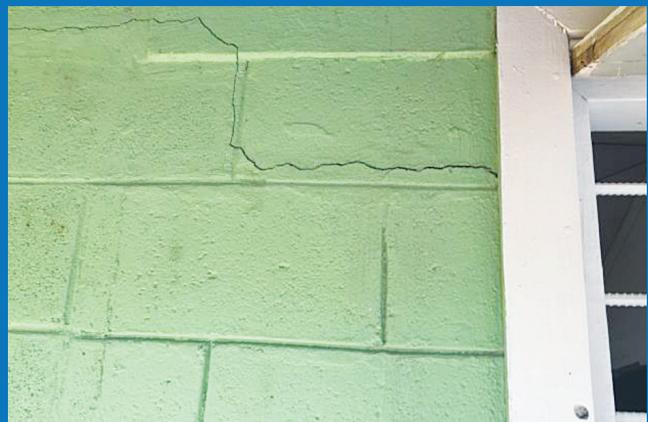
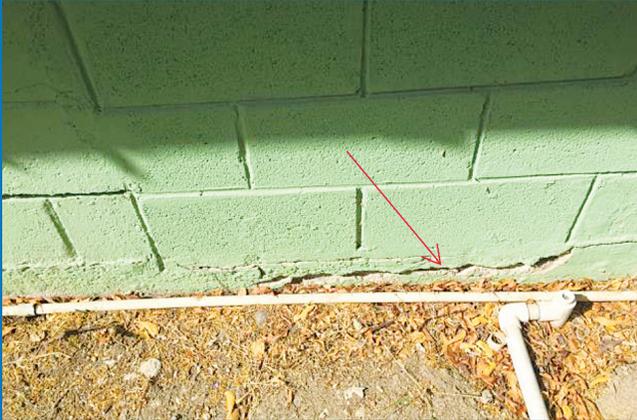
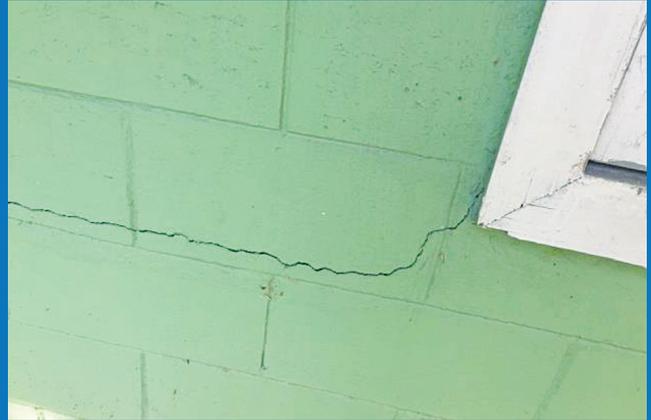
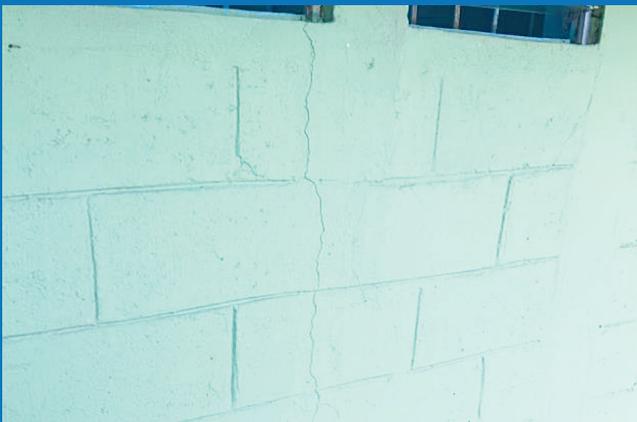
■ SOME CRACKS TO EXTERNAL WALLS

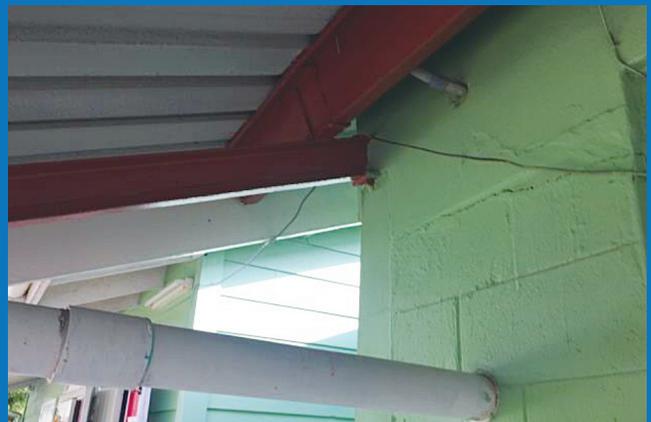
■ EXPOSED SECTION OF STRUCTURAL STEEL ROOF FRAME

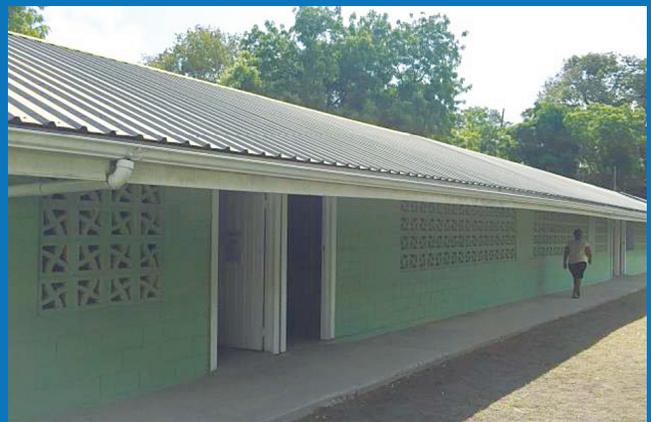
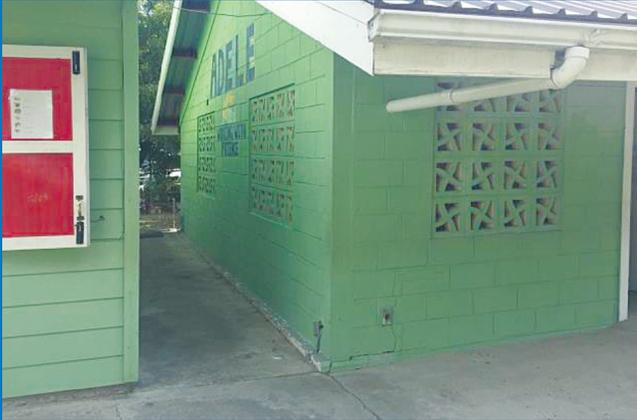
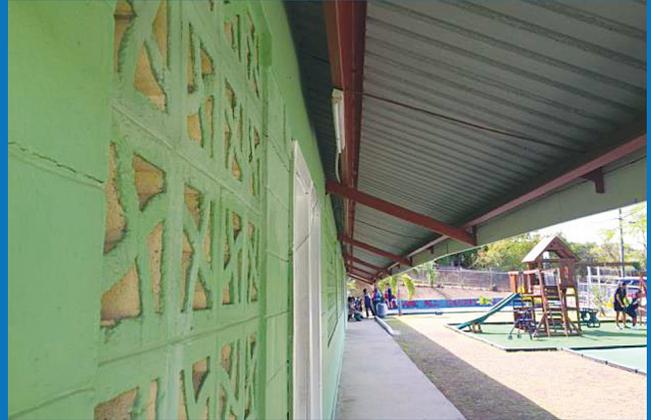
■ VENT BLOCKS AND DOORS TO OPEN CORRIDOR - NO WINDOWS

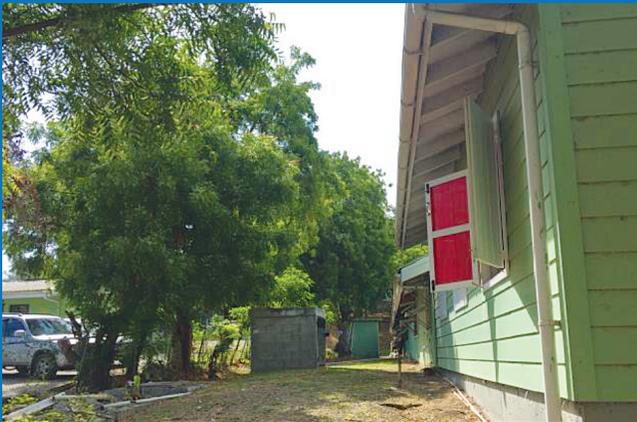
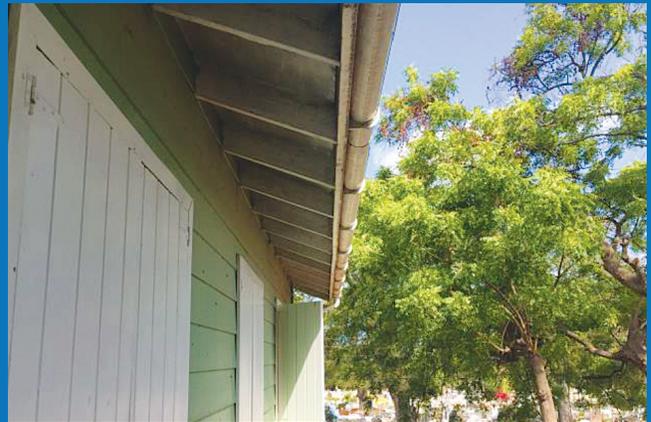
■ TALL TREES IN CLOSE PROXIMITY TO BUILDINGS

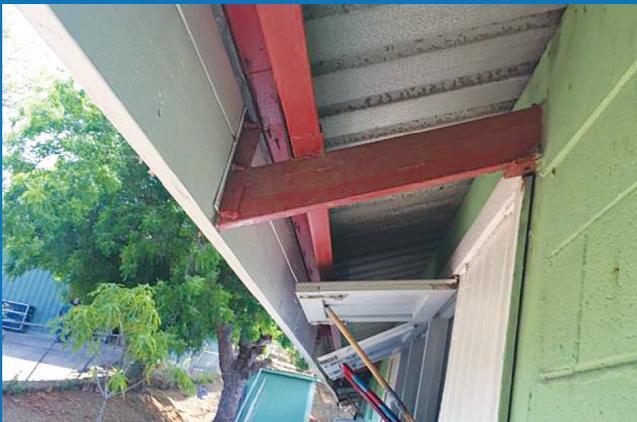
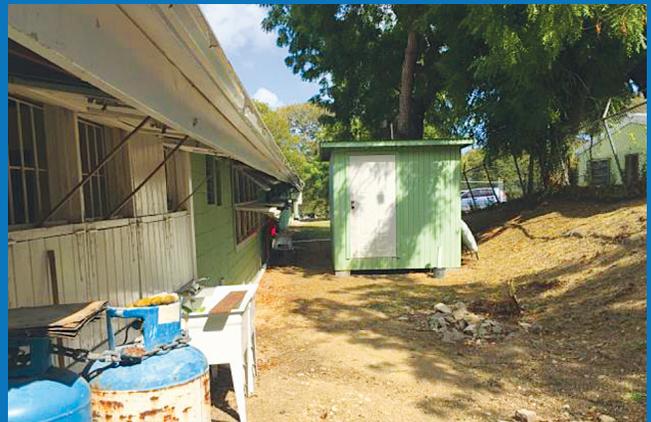
■ TIMBER WINDOWS
- TO ONE SIDE OF BUILDING

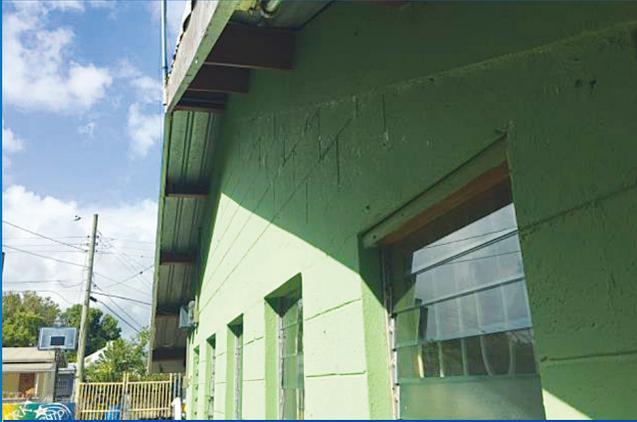
■ CORRODED ELECTRICS

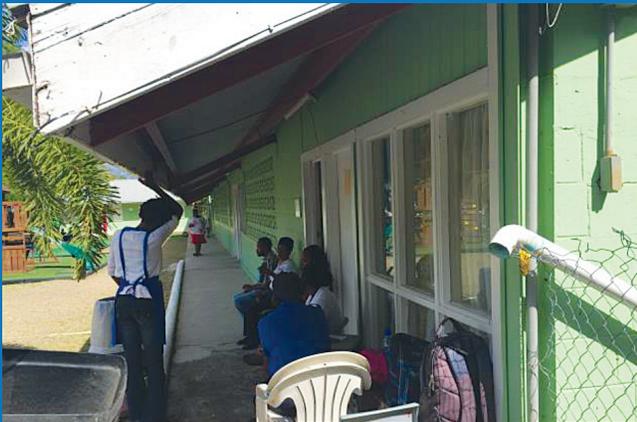
■ TIMBER CLADDING IN NEED OF REPAIR

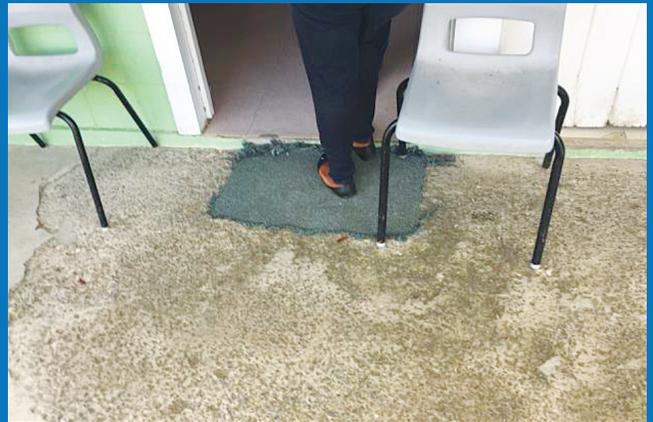
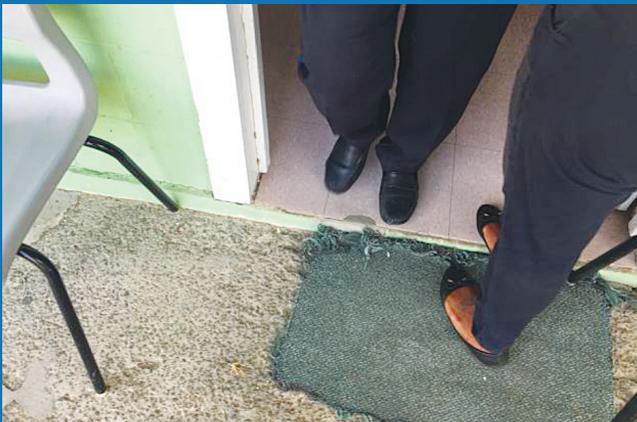
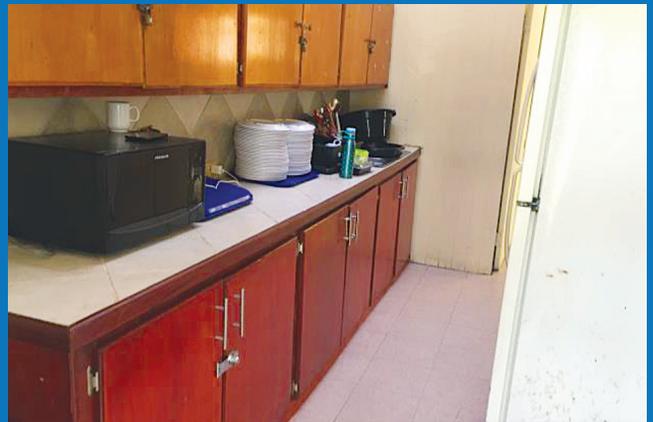
■ KITCHEN AREA FLOODS EASILY

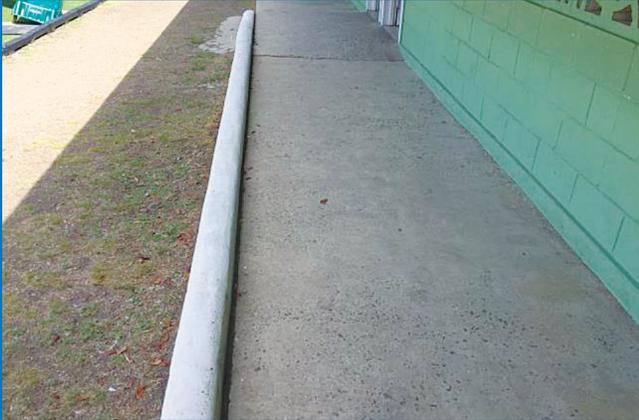
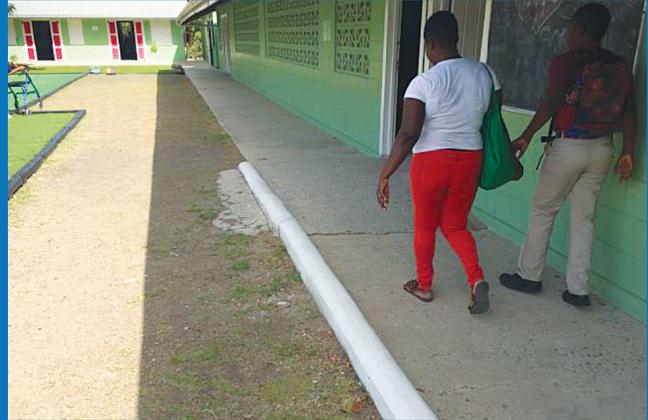
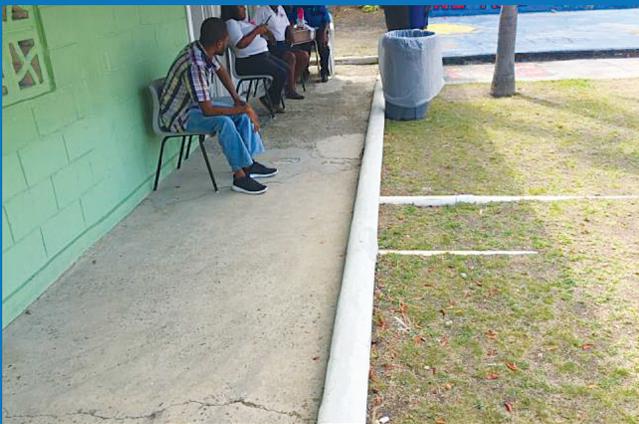
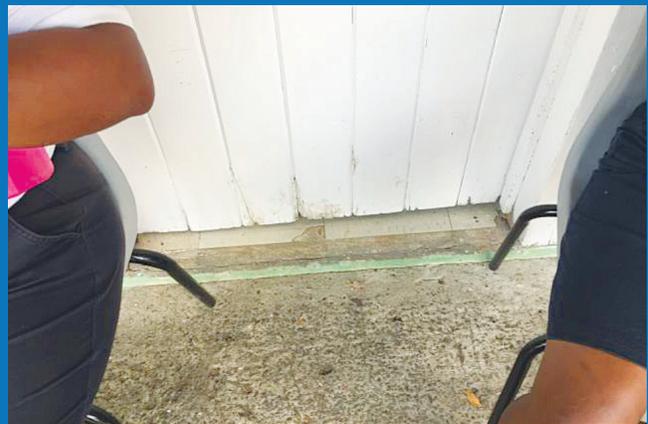
■ CURB WALL ERECTED TO MITIGATE FLOODING-RELATED PROBLEMS
