IMPLEMENTATION OF THE MODEL SAFE SCHOOL PROGRAMME IN THE CARIBBEAN

HAZARD RISK ASSESSMENT REPORT AND COSTED ACTION PLAN

OTTOS COMPREHENSIVE SECONDARY SCHOOL

ANTIGUA AND BARBUDA

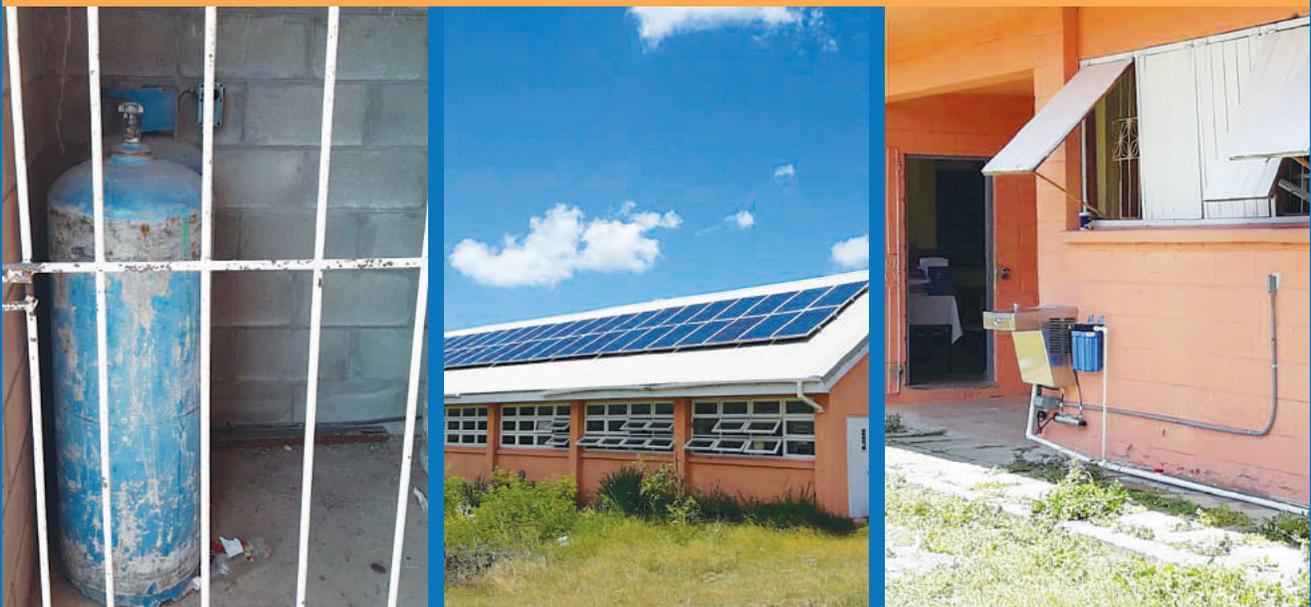
FIGURE 7.1: SOME EXAMPLES OF KEY STRENGTHS AT THE OTTOS COMPREHENSIVE SECONDARY SCHOOL (E.G. PROPERLY SECURED LPG TANKS, SOLAR PANELS, FILTRATION SYSTEM OBSERVED ON WATER DISPENSERS)

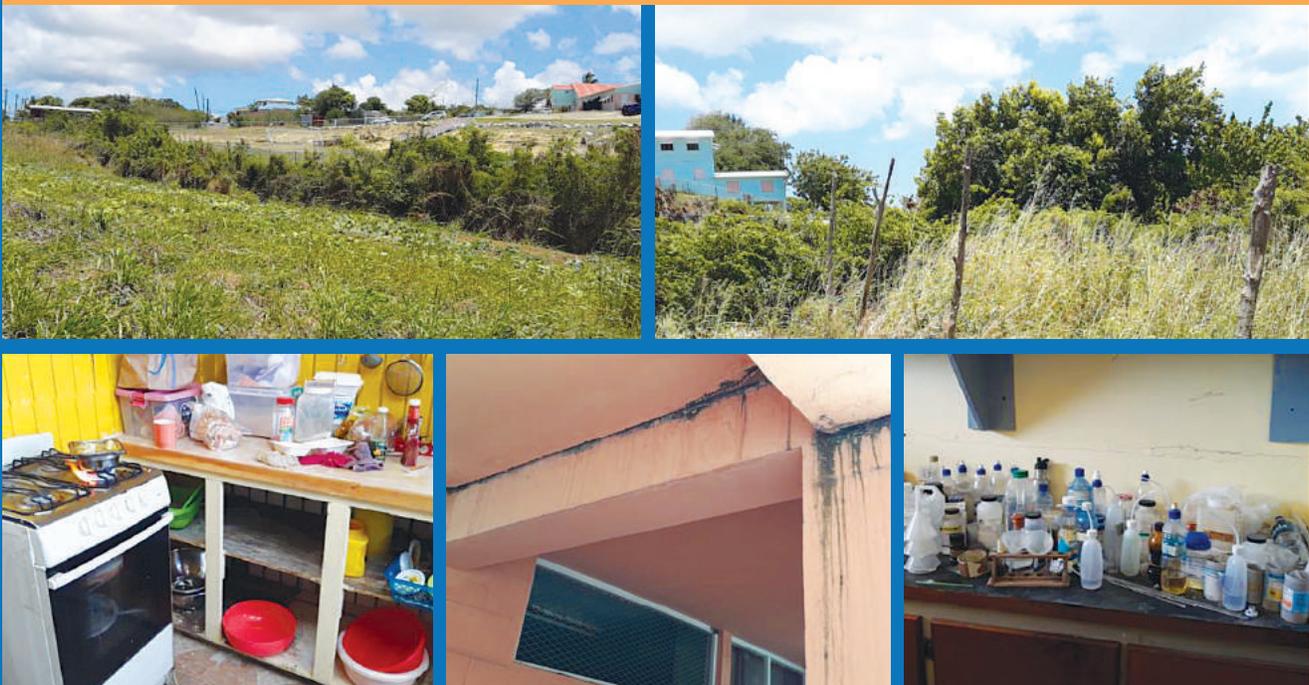
- At the time of the assessment, the school did not have a proper chemical storage space for cleaning products. The cleaners keep some chemicals in sections of the student bathrooms. The principal indicate that he was working on getting special cupboards to store chemicals in the existing pump room which a secure room.
- Chemical management in the labs needs much improvement. Some chemicals were not properly stored, and labels are no longer visible (see images below).
- No emergency eyewash station or showers were observed.

FIGURE 7.2: EXAMPLES OF AREAS FOR IMPROVEMENT

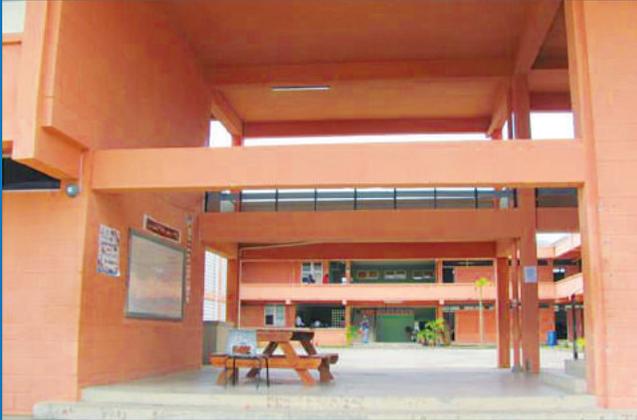
■ CLASSROOM BLOCK
- REDUCED NATURAL VENTILATION

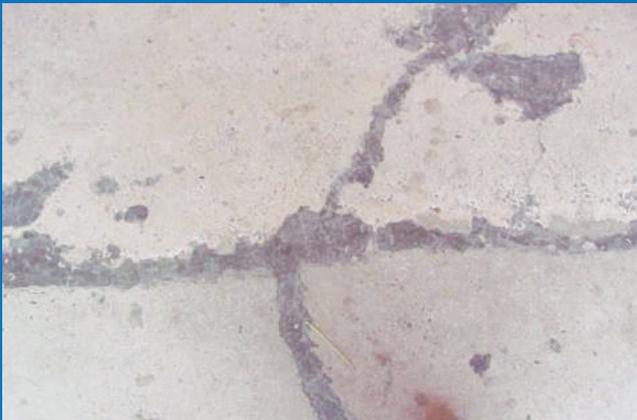
■ SPALLING CONCRETE

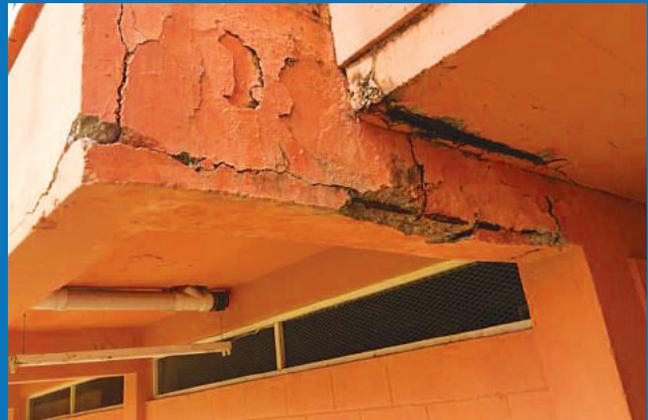
■ SPALLING CONCRETE

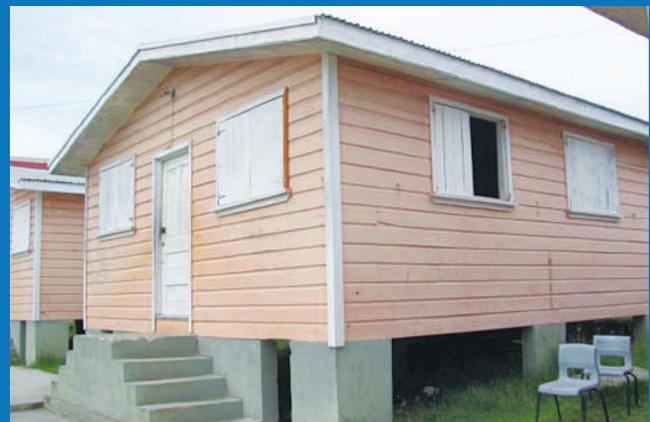
■ BROKEN WINDOW

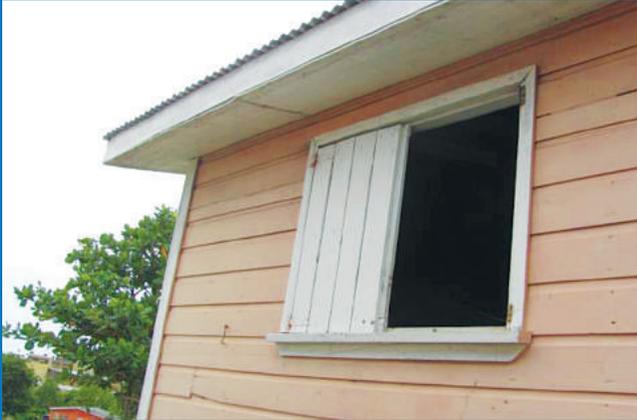
■ CORRODED HINGES

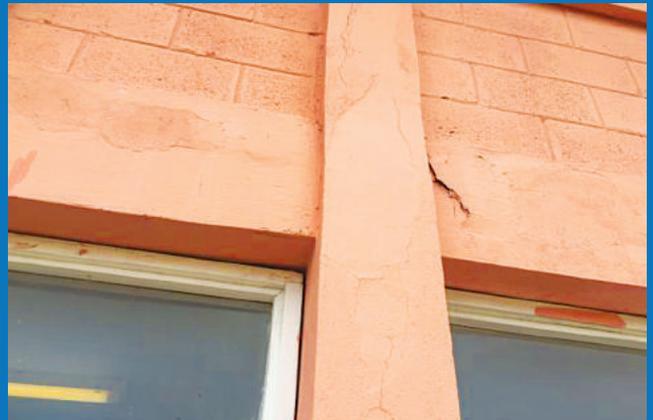
■ VERTICAL CRACKS IN COLUMNS

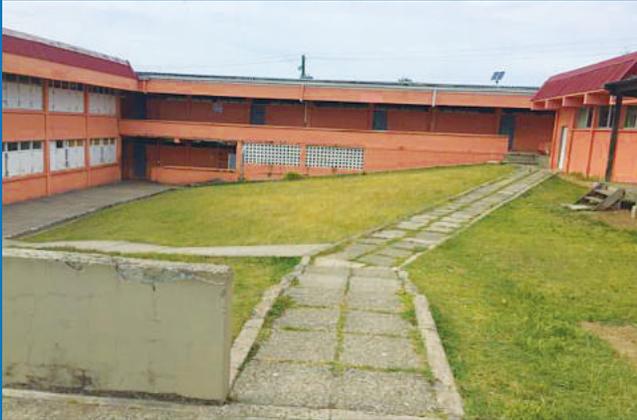
■ INTERNAL CIRCULATION OPENED TO THE ELEMENTS

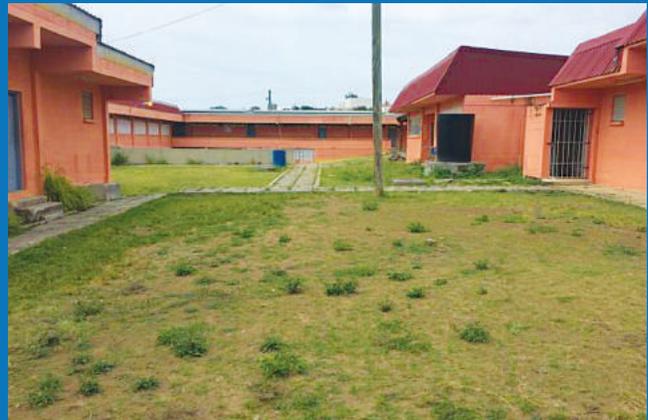
■ SECTION OF YARD OVERGROWN BY SHRUBBERY

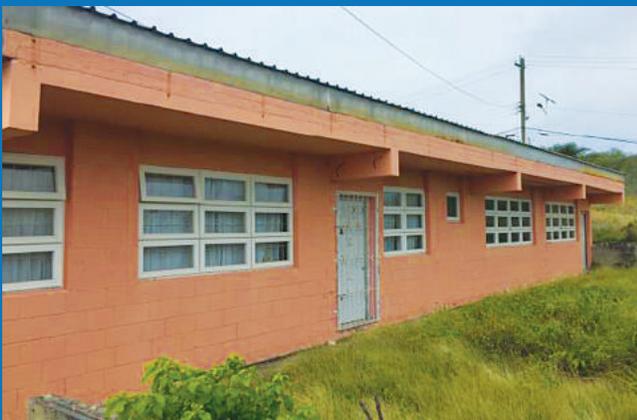
■ UTILITY POLES IN CLOSE PROXIMITY TO BUILDINGS

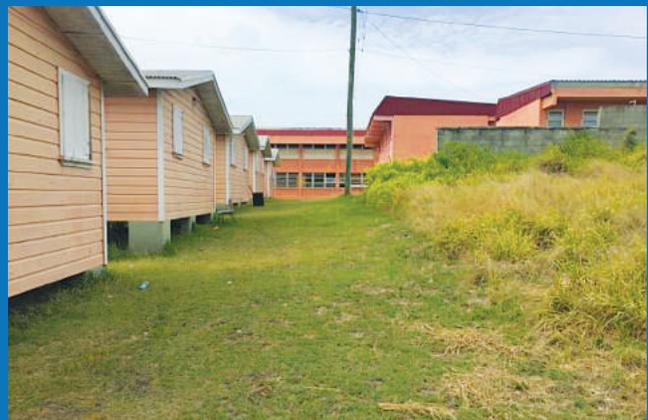
■ UTILITY POLES IN CLOSE PROXIMITY TO BUILDINGS
