IMPLEMENTATION OF THE MODEL SAFE SCHOOL PROGRAMME IN THE CARIBBEAN

# HAZARD RISK ASSESSMENT REPORT AND COSTED ACTION PLAN

## BELLES PRIMARY SCHOOL

DOMINICA

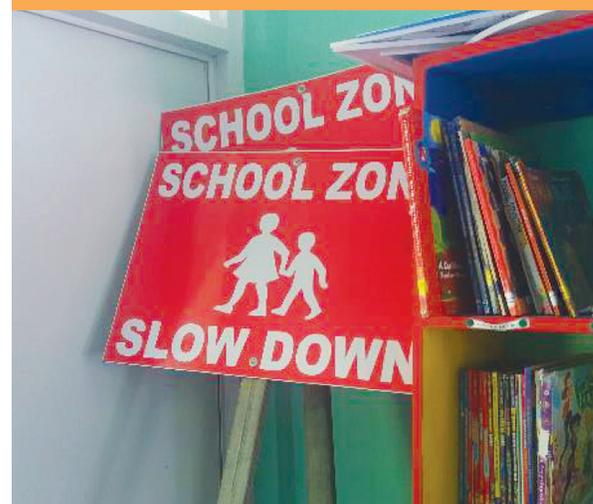
FIGURE 4.7: SAFETY SIGNS TO BE ERECTED AT BELLES PRIMARY SCHOOL (MAY 2019)

During interviews with persons at the Belles Primary School, a major concern was proximity to the highway and the lack of infrastructure to protect persons on the premises in the case of an accident/collision. Only a chain-link fence separates the small compound from the highway. The school administration expressed that they requested for a wall or more substantial barrier to be put in place through the District Education Office of the Ministry of Education (MoE). They have also since take the initiative to have safety signs made, however at the time of the assessment these had not yet been erected (Figure 4-7); given that students must cross the road to access evacuation assembly points/safety areas, this issue is paramount. The school also does not have any security personnel on staff, however there is a perimeter fence that is fully intact, and they have a close working relationship with residents of the Belles village where they are located.

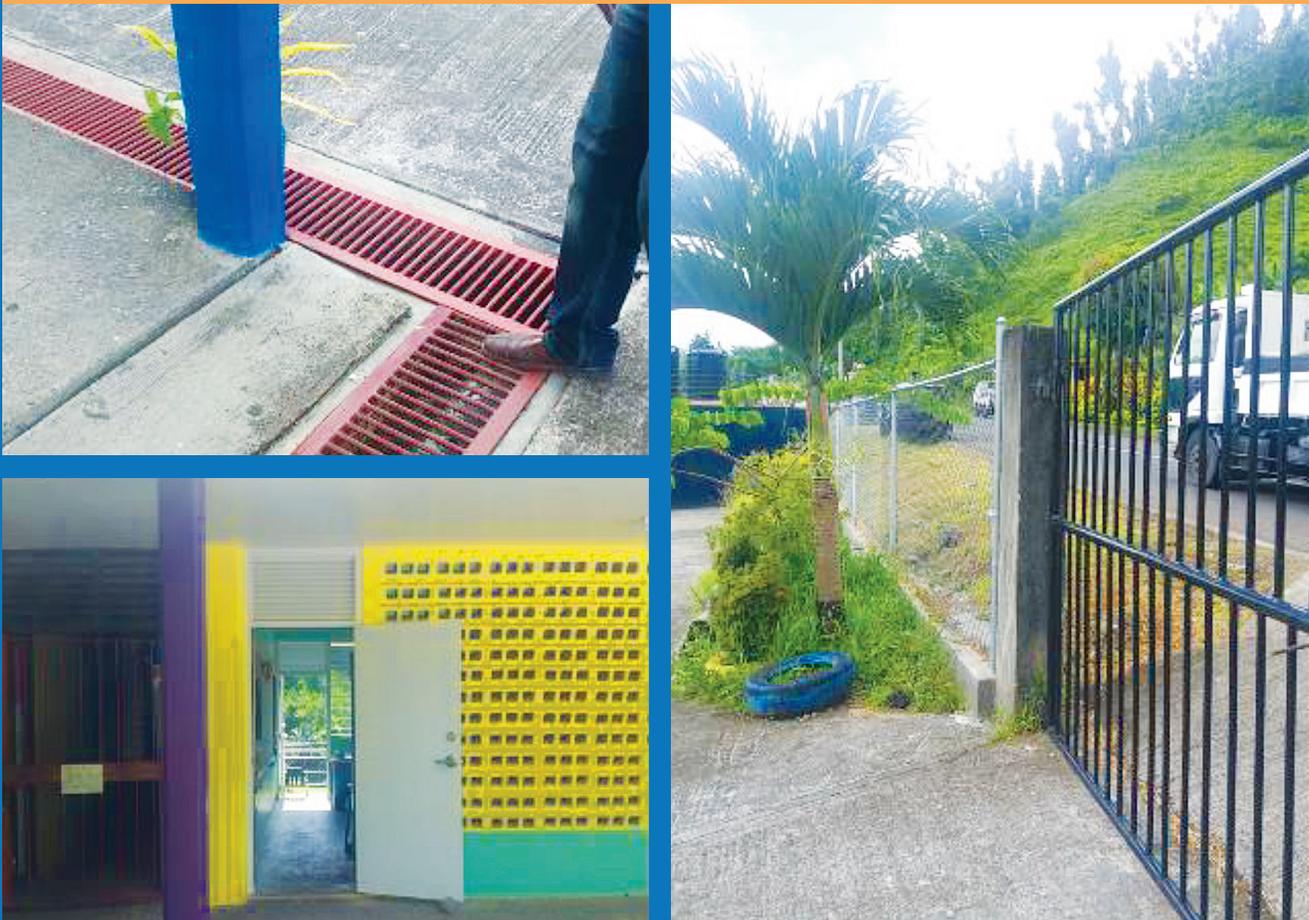
FIGURE 7.1: IMAGES HIGHLIGHTING SAFETY STRENGTH AT BELLES PRIMARY SCHOOL (MAY 2019)

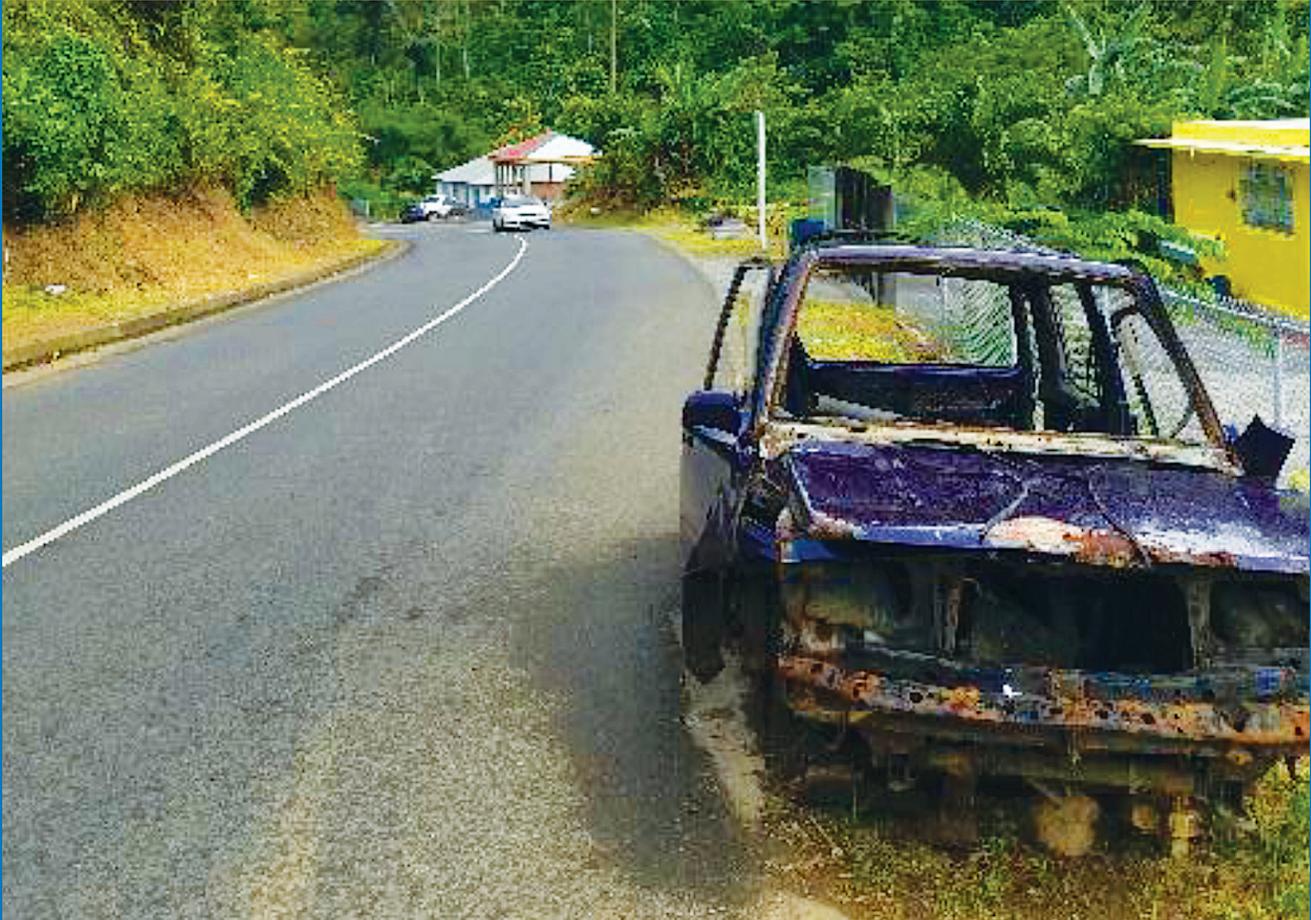
**FIGURE 7.2: IMAGE ILLUSTRATING PROXIMITY OF SCHOOL TO MAJOR HIGHWAY AND LACK OF SAFETY SIGNAGE (MAY 2019)**

Section 8 – Improvement Plan and Costed Action Plan provided specific actions and timelines for recommendations on improving the overall safety of the school. Additional selected photographs can be found in the Appendix.

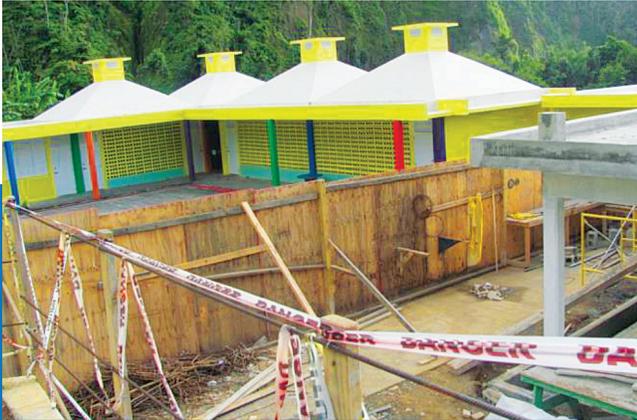
■ PANORAMIC VIEW SHOWING EXISTING FACILITY WITH EXPANSION WORK IN PROGRESS

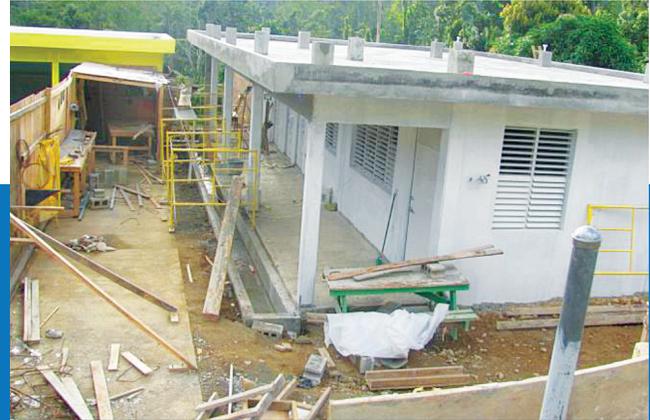
■ EXPANSION WORK IN PROGRESS
