# HAZARD RISK ASSESSMENT REPORT AND COSTED ACTION PLAN

## ELLERSLIE SCHOOL

BARBADOS

Original Submission Date: November 12, 2019

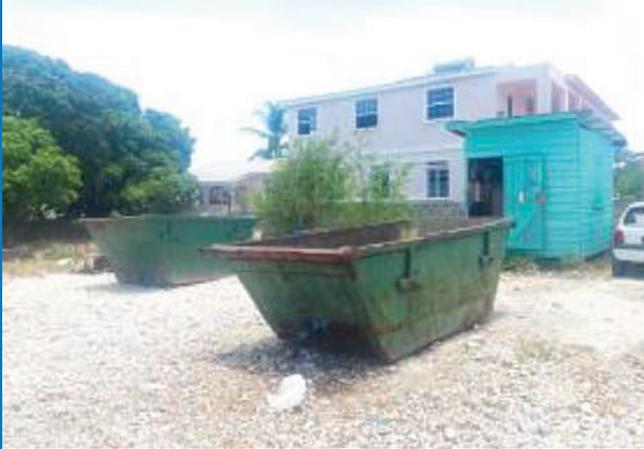
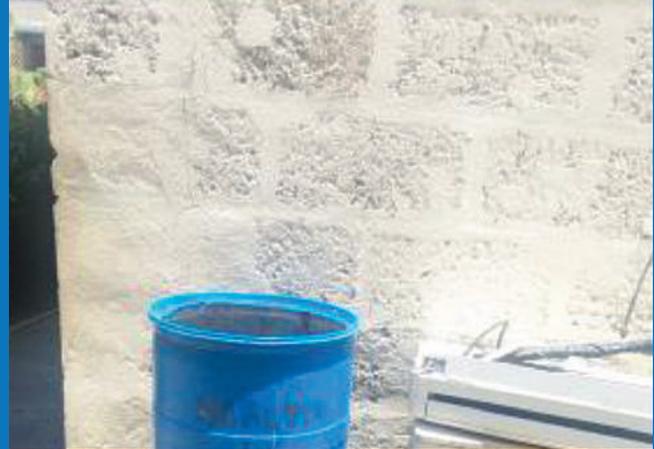
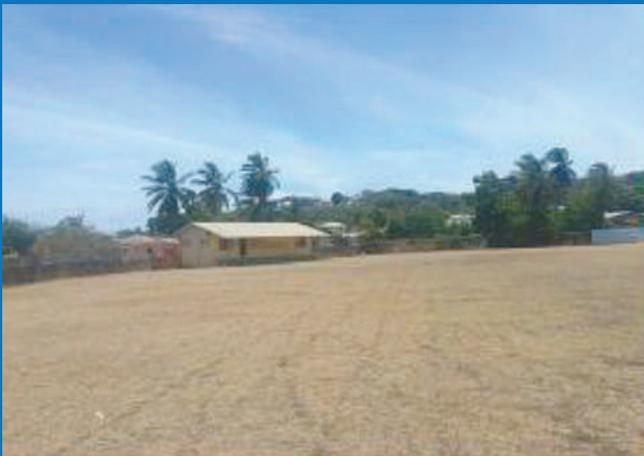
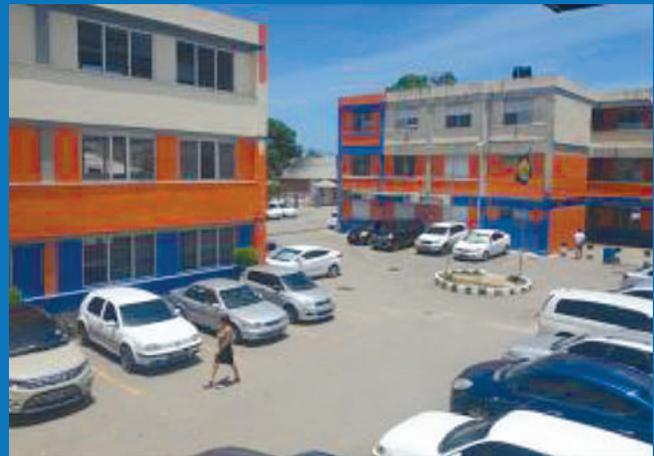
FIGURE 7.2: SELECTED PICTURES OF ELLERSLIE SCHOOL SHOWING SOME KEY AREAS FOR IMPROVEMENT (LEFT TO RIGHT: OPEN RECEPTACLES, PERIMETER FENCE IN NEED OF REPAIR AND TREE TRIMMING, WINDOWS WITHOUT MESH/SOME BROKEN WINDOWS)

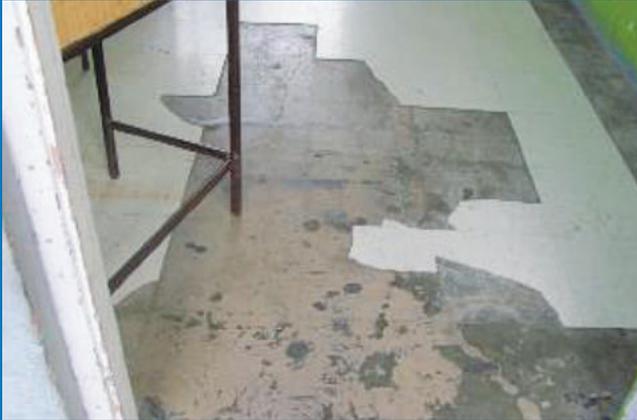
■ BROKEN FLOOR TILES

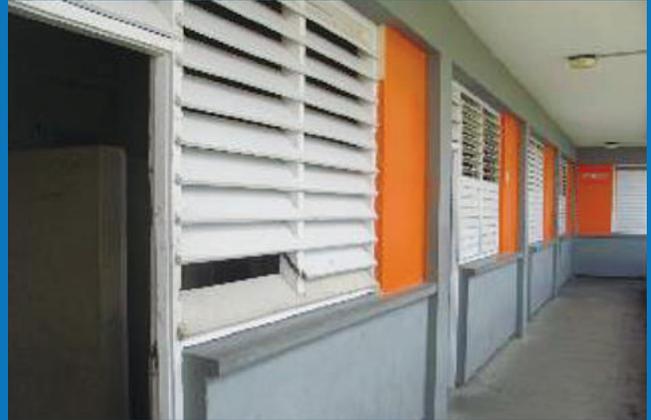
■ BROKEN WINDOW

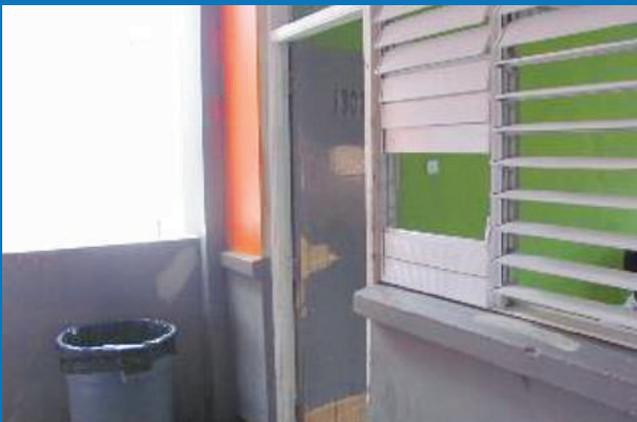
■ BROKEN WINDOW

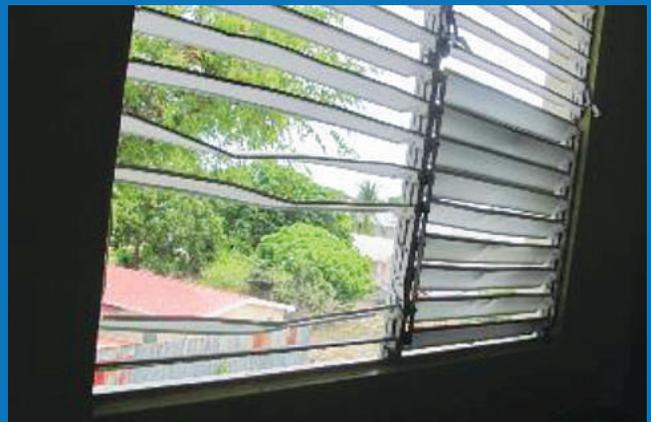
■ BROKEN WINDOW

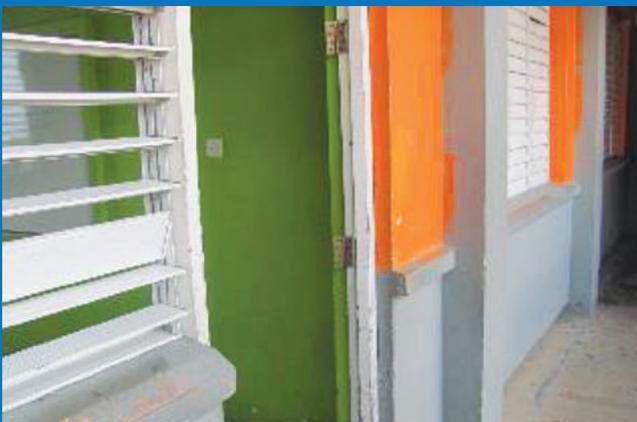
■ BROKEN DOOR

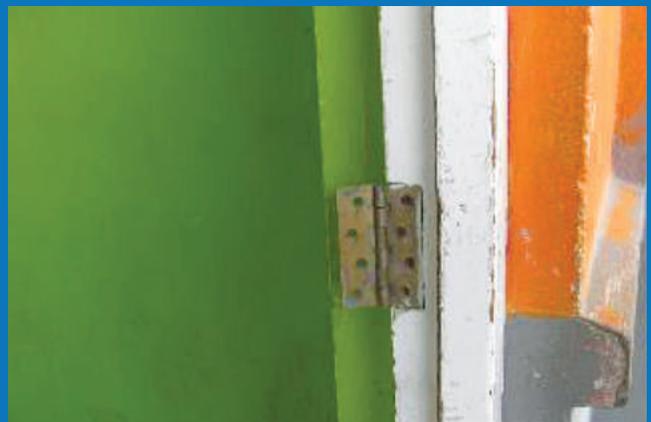
■ BROKEN DOOR

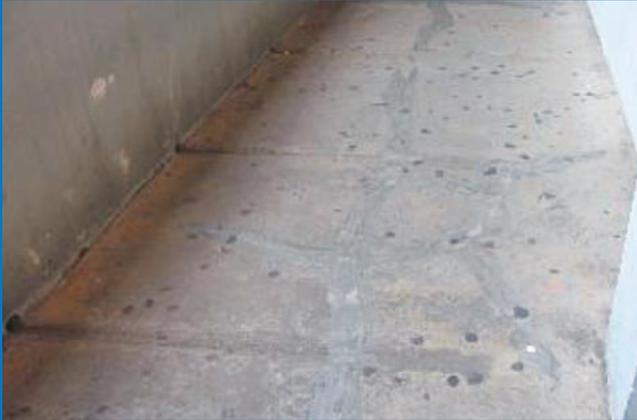
■ FLOOR SLAB – REPAIRED CRACKS

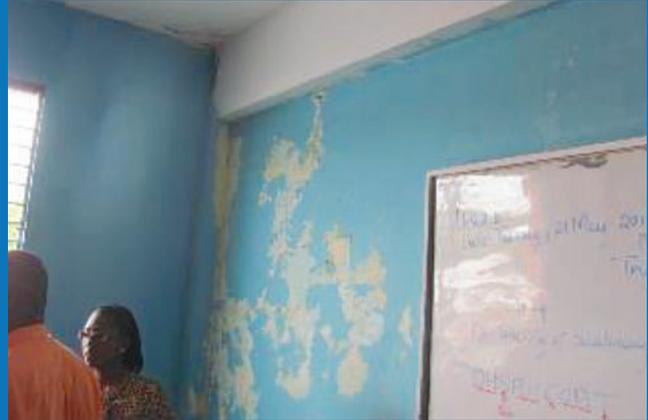
■ POSSIBLE SIGNS OF MOLD

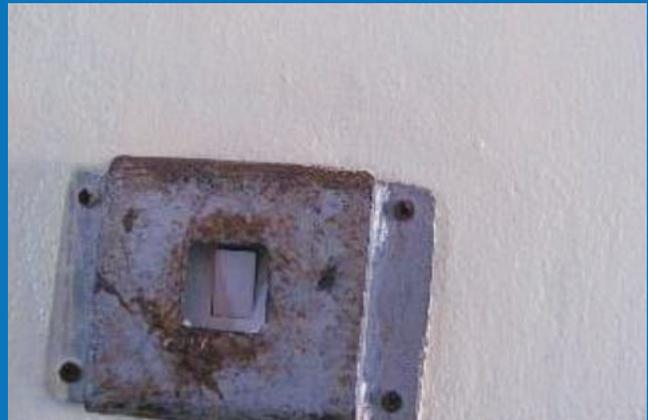
■ ELECTRICAL SWITCH PROTECTIVE PLATE

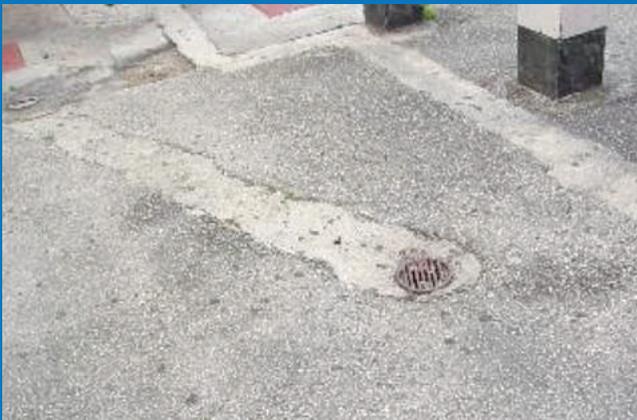
■ STORM WATER INTAKE APPEARS INADEQUATE

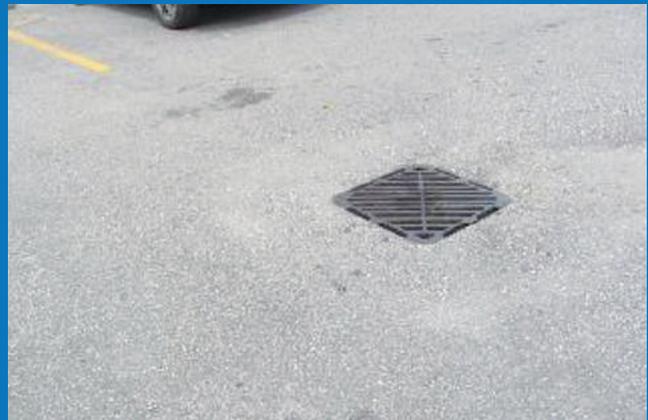
■ STORM WATER INTAKE APPEARS INADEQUATE
