IMPLEMENTATION OF THE MODEL SAFE SCHOOL PROGRAMME IN THE CARIBBEAN

HAZARD RISK ASSESSMENT REPORT AND COSTED ACTION PLAN

MARY E. PIGOTT
PRIMARY SCHOOL

ANTIGUA AND BARBUDA

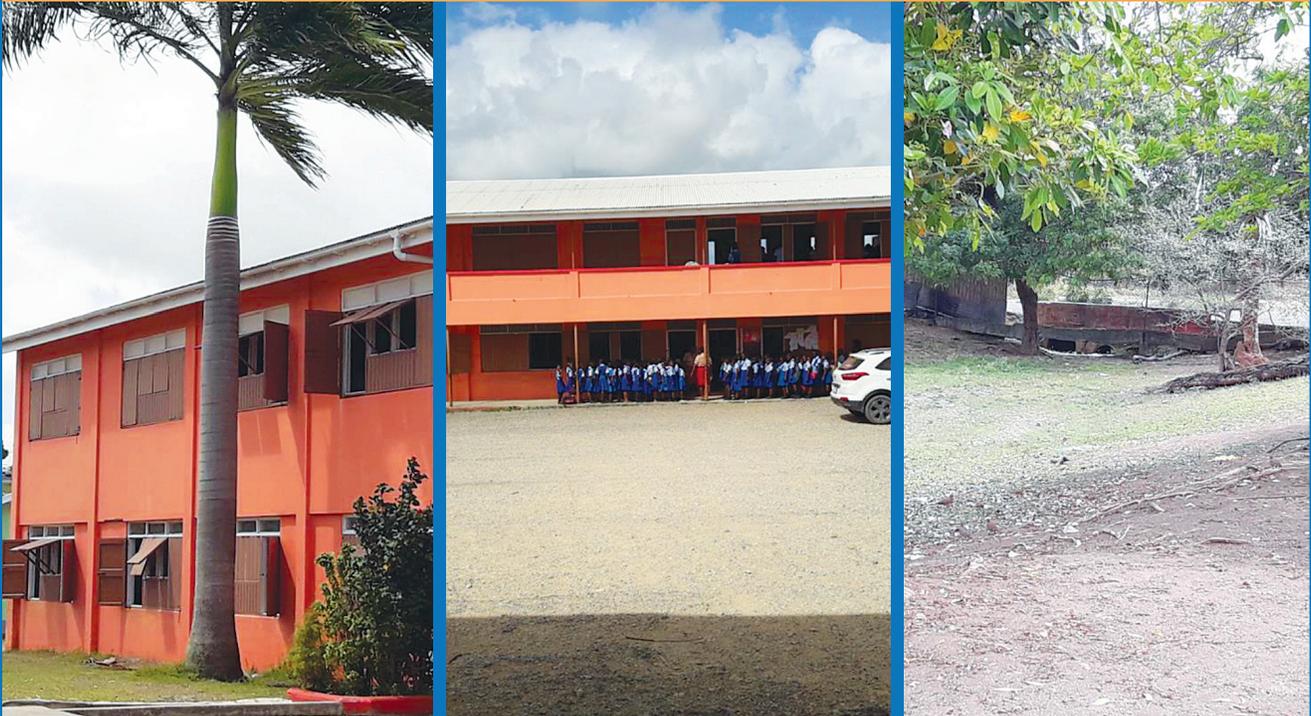
FIGURE 7.2: EXAMPLES OF AREAS FOR IMPROVEMENT

- The lack of security in the evenings and on weekends is a major concern. The school was broken into in the past.
- There was no observed visitor sign-in procedure being enforced

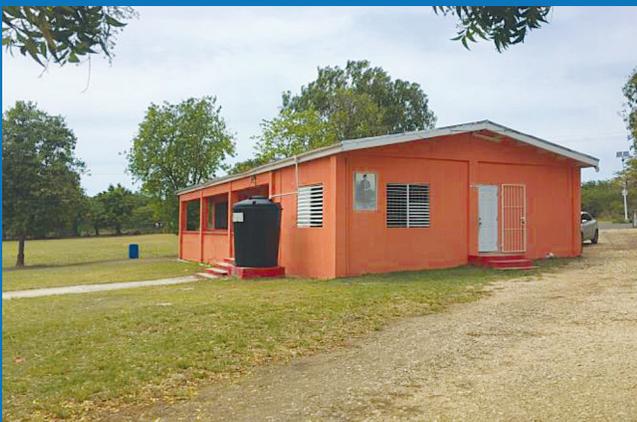
■ DETACHED BLOCK
- NO COVERED LINKAGE TO MAIN COMPOUND

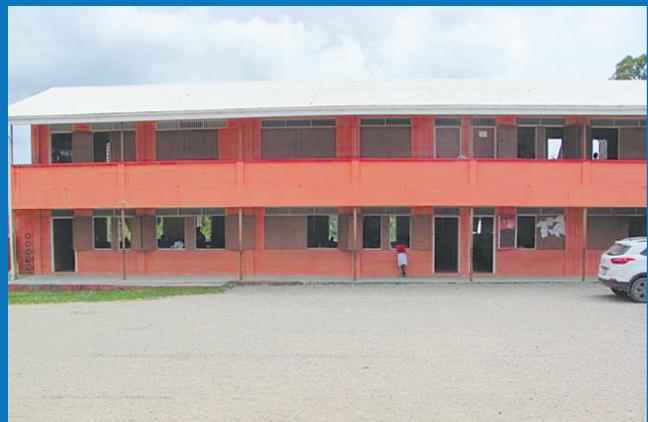
■ DETACHED BLOCK
- NO COVERED LINKAGE TO MAIN COMPOUND

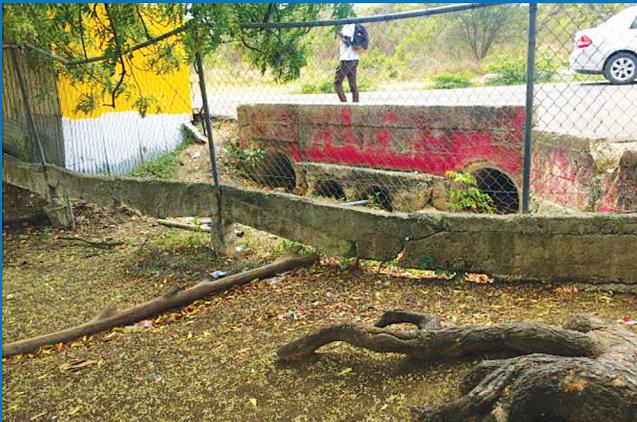
■ MAJOR WATERWAY FLOWS THROUGH SCHOOL COMPOUND IN SHALLOW DITCH

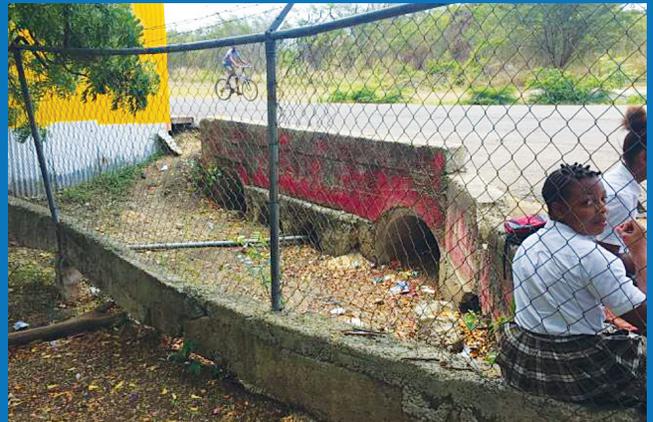
■ MAJOR WATERWAY FLOWS THROUGH SCHOOL COMPOUND IN SHALLOW DITCH

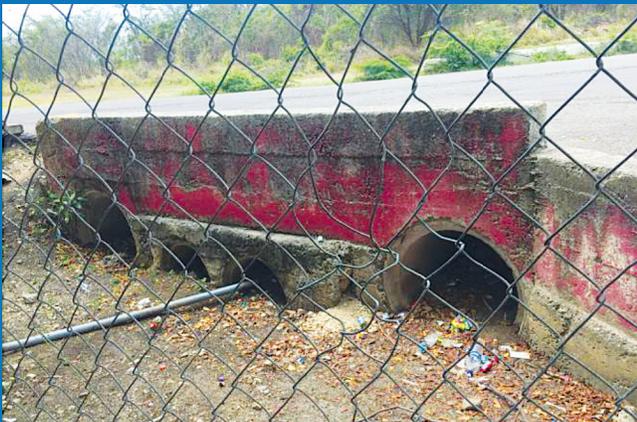
■ MAJOR WATERWAY FLOWS THROUGH SCHOOL COMPOUND IN SHALLOW DITCH

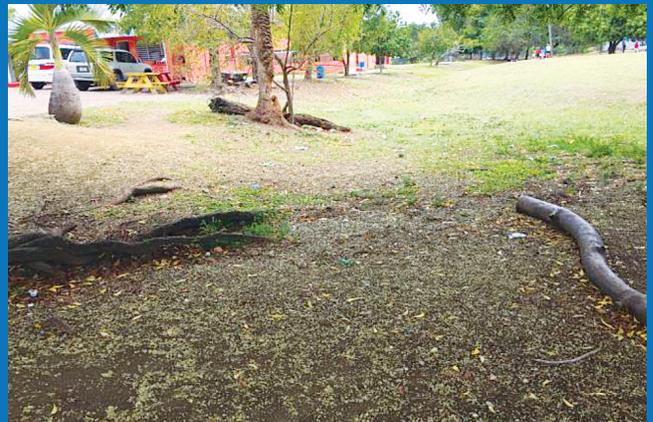
■ MAJOR WATERWAY FLOWS THROUGH SCHOOL COMPOUND IN SHALLOW DITCH

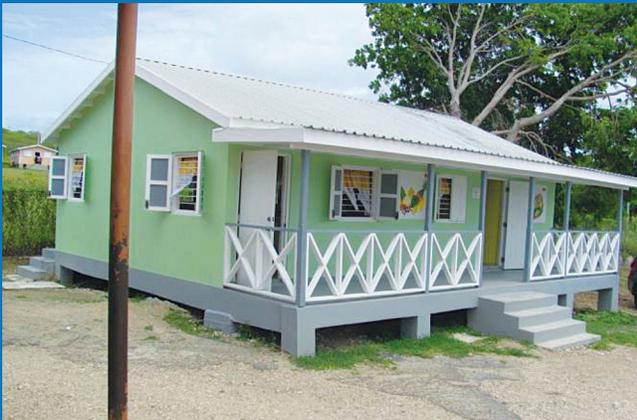
■ SCHOOL MEALS PROGRAMME
IN SMALL WOODEN BUILDING

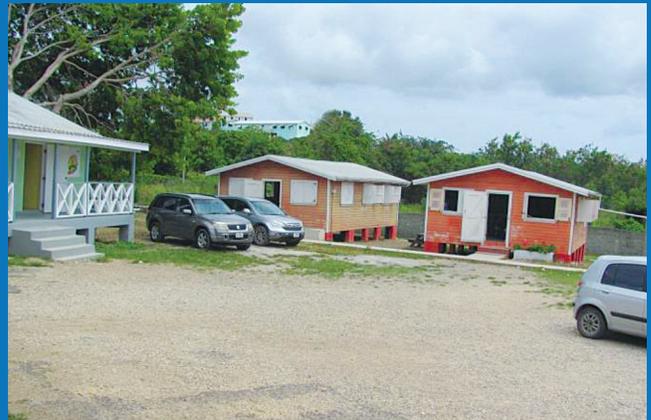
■ INFANTS ACCOMMODATED
IN SMALL WOODEN BUILDINGS

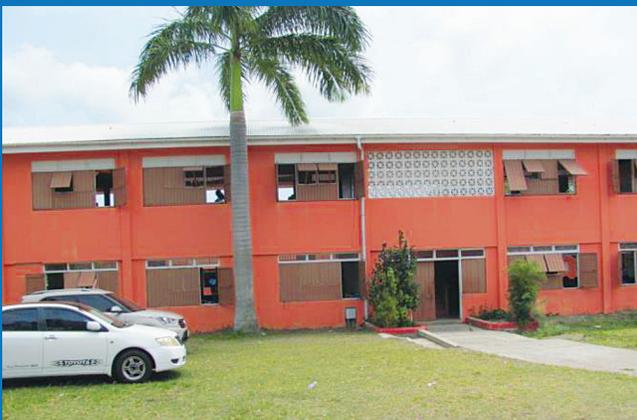
■ ADJACENT PALM TREE IN
CLOSE PROXIMITY TO BUILDING
