IMPLEMENTATION OF THE MODEL SAFE SCHOOL PROGRAMME IN THE CARIBBEAN

HAZARD RISK ASSESSMENT REPORT AND COSTED ACTION PLAN

DENNERY PRIMARY SCHOOL

SAINT LUCIA

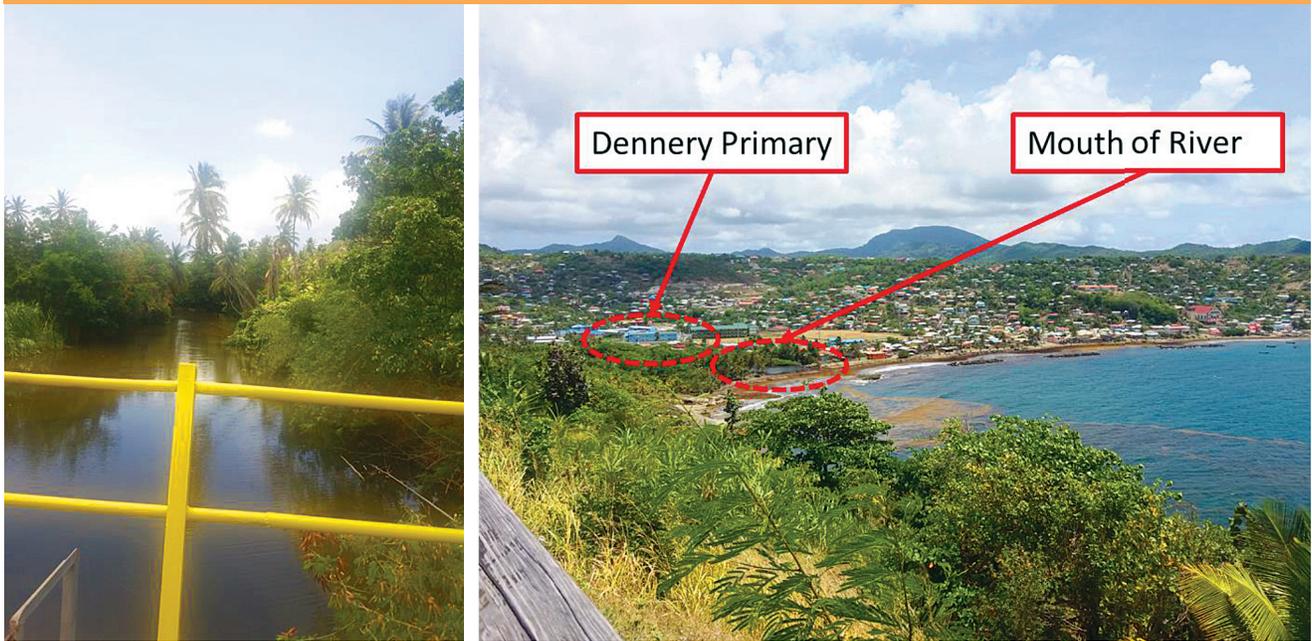
FIGURE 4.2: IMAGES OF DENNERY PRIMARY – RIVER RUNS SOUTH OF THE SCHOOL AND EMPTIES INTO DENNERY BAY

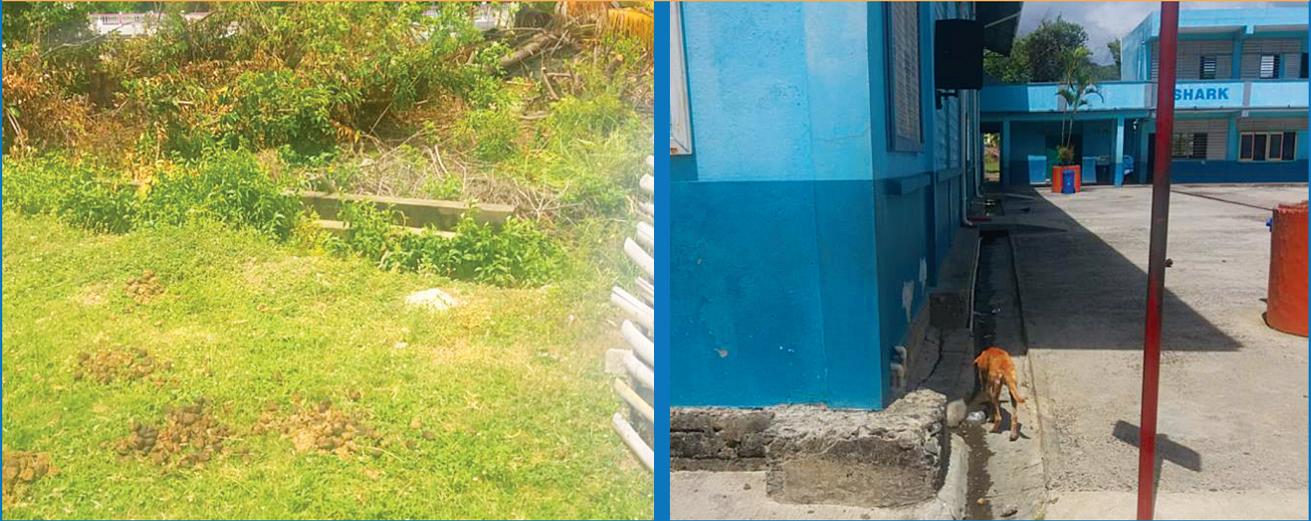
FIGURE 7.1: EVIDENCE OF STRAY ANIMALS ROAMING THROUGH SCHOOL COMPOUNDS (MAY 2019)

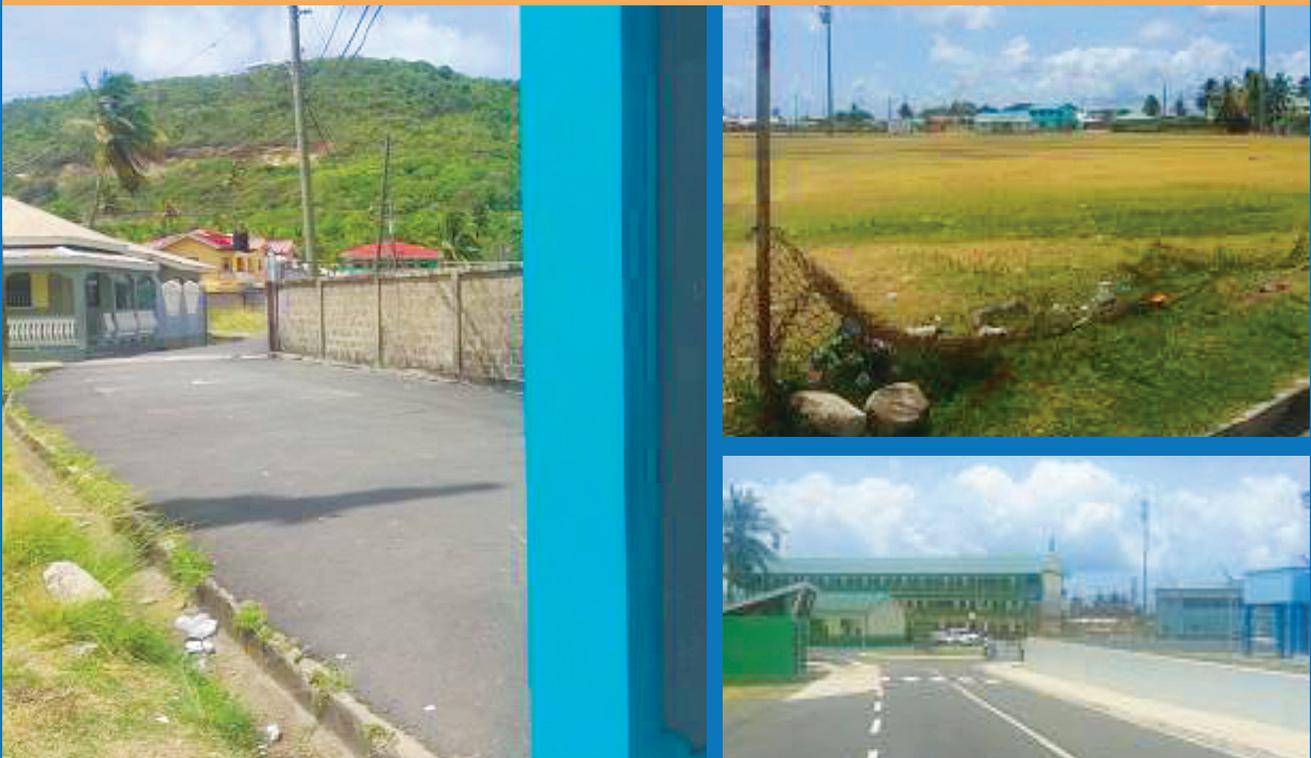
FIGURE 7.2: EVIDENCE OF SEVERAL UNSECURED ENTRY POINTS (MAY 2019)

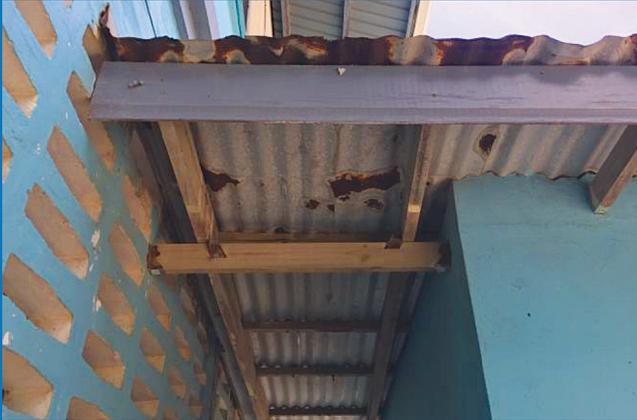
■ CORRODED ROOF SHEETS

- Some repairs required to the physical plant to ensure safety before or during a hazard event. Particular focus should be given to roof repair and storm water drainage.

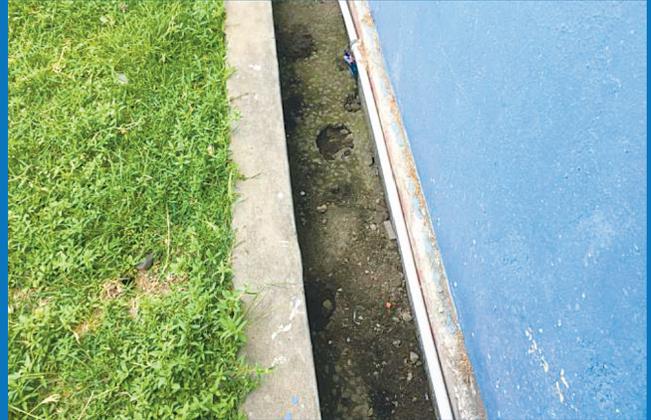
■ STORM DRAINS

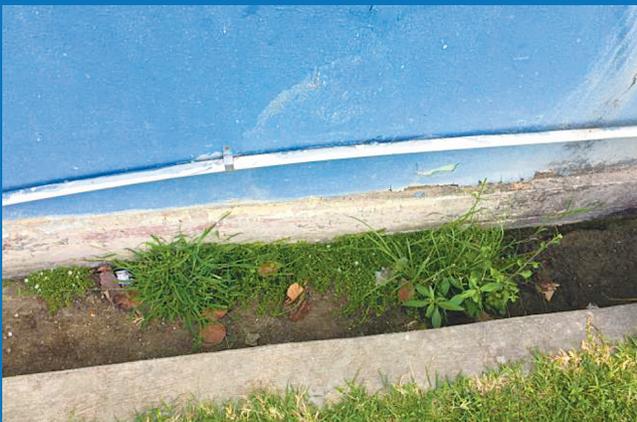
■ STORM DRAINS

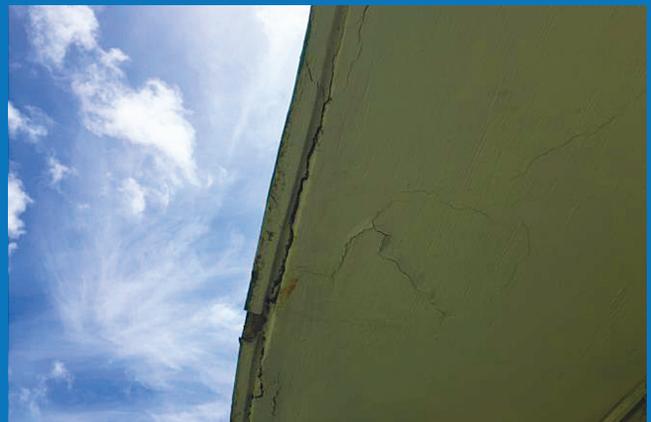
■ SPALLING CONCRETE

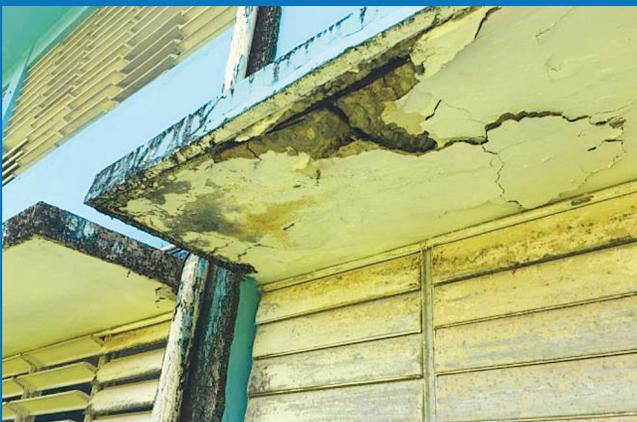
■ SPALLING CONCRETE

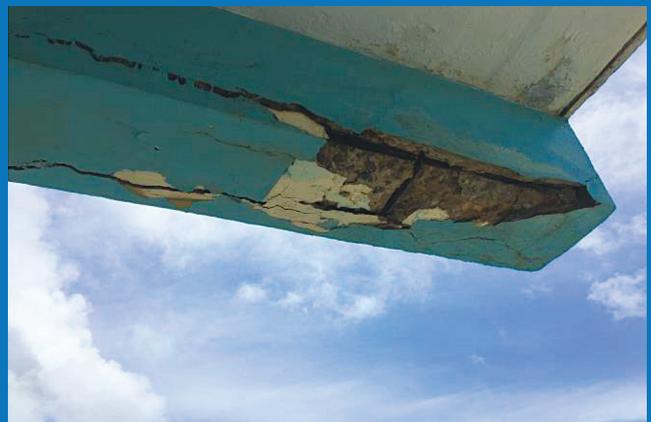
■ SPALLING CONCRETE

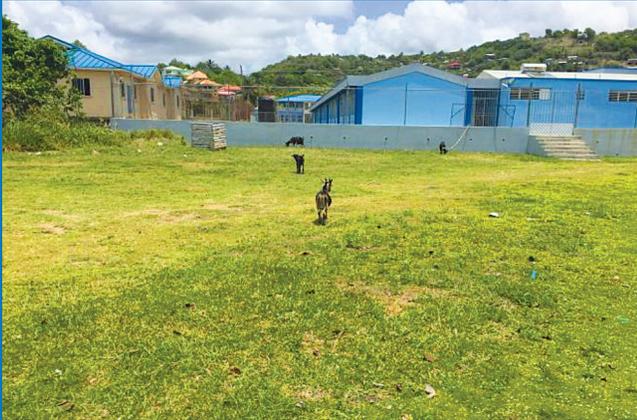
■ ANIMALS GRAZING IN PLAYING AREA

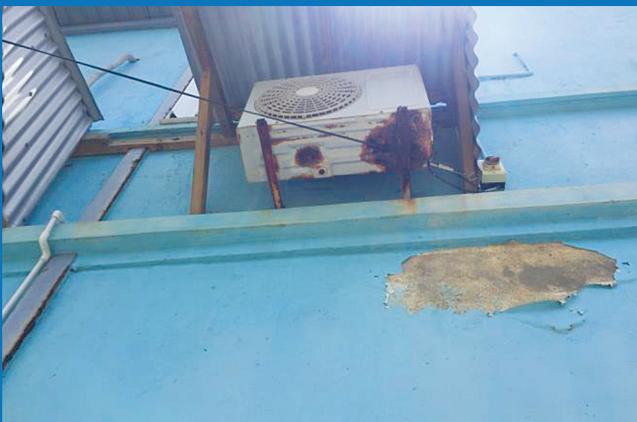
■ CORRODED AIR-CONDITION UNIT

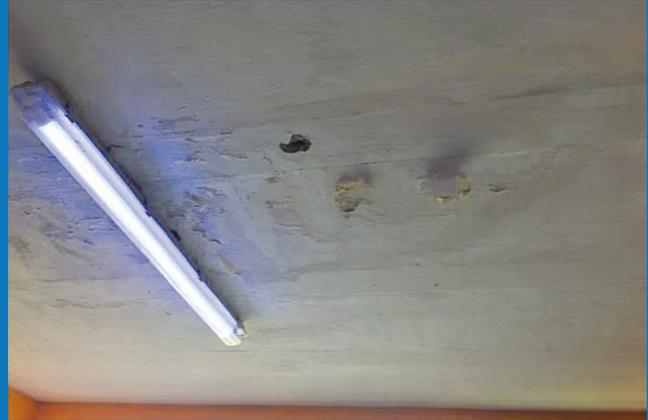
■ SIGNS OF WATER INGRESS

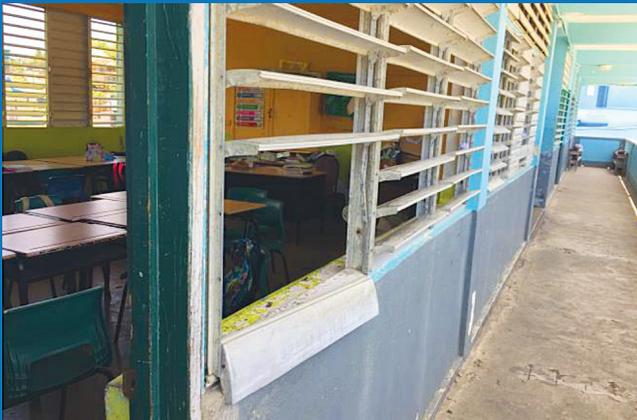
■ BROKEN WINDOWS
