EFFECTS OF WEATHERING IN THE ROCK AND ROCK MASS PROPERTIES AND THE INFLUENCE OF SALTS IN THE COASTAL ROADCUTS IN SAINT VINCENT AND DOMINICA

Thesis submitted to the Faculty of Geo-Information Science and Earth
Observation of the University of Twente in partial fulfilment of the
requirements for the degree of Master of Science in Geo-information Science
and Earth Observation.

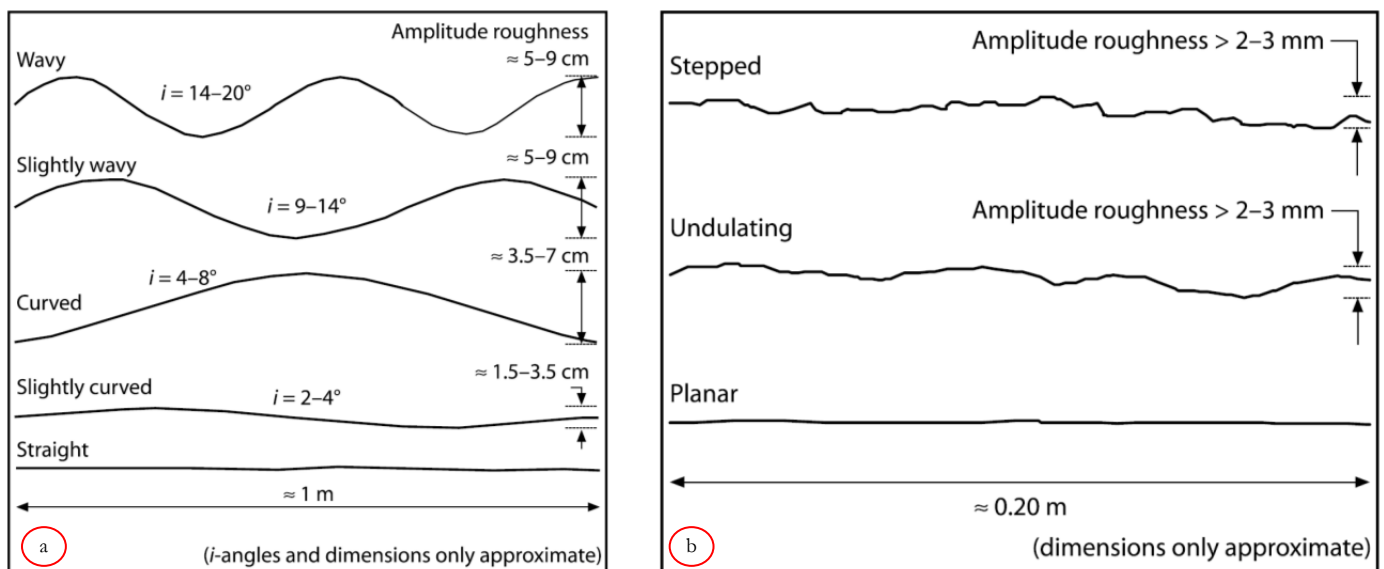
Figure 2. Description of large-scale (Rl) and small-scale (Rs) roughness of discontinuities; (a) Rl is determined in 1 m x 1 m area; (b) Rs is determined in 20 cm x 20 cm area of the discontinuity plane (Hack, 1998)

a. Large-scale (Rl) and small-scale (Rs) roughness - The importance of the discontinuity surface roughness on the shear strength along the discontinuity planes depends on the stress configuration on the discontinuity plane and in the deformation characteristic of the discontinuity wall material and asperities (Hack, 1998). These are explained in detail in the SSPC System. The Rl and Rs were measured by assessing the wavelength and amplitudes of the discontinuity surface using the Figures 2a and 2b as reference. In the SSPC system, the ISRM profiles were modified for a new empirical relation consisting of a combination of tactile and visible roughness. The large-scale roughness is determined in an area larger than 20 cm x 20 cm but smaller than 1 m x 1 m. It is described in five classes namely wavy, slightly wavy, curved, slightly curved and straight. Tactile roughness is classified as rough, smooth and polished as distinguished by feeling the discontinuity surface with the fingers in an area of 20 cm x 20 cm. The small-scale roughness is described as stepped, undulating and planar.

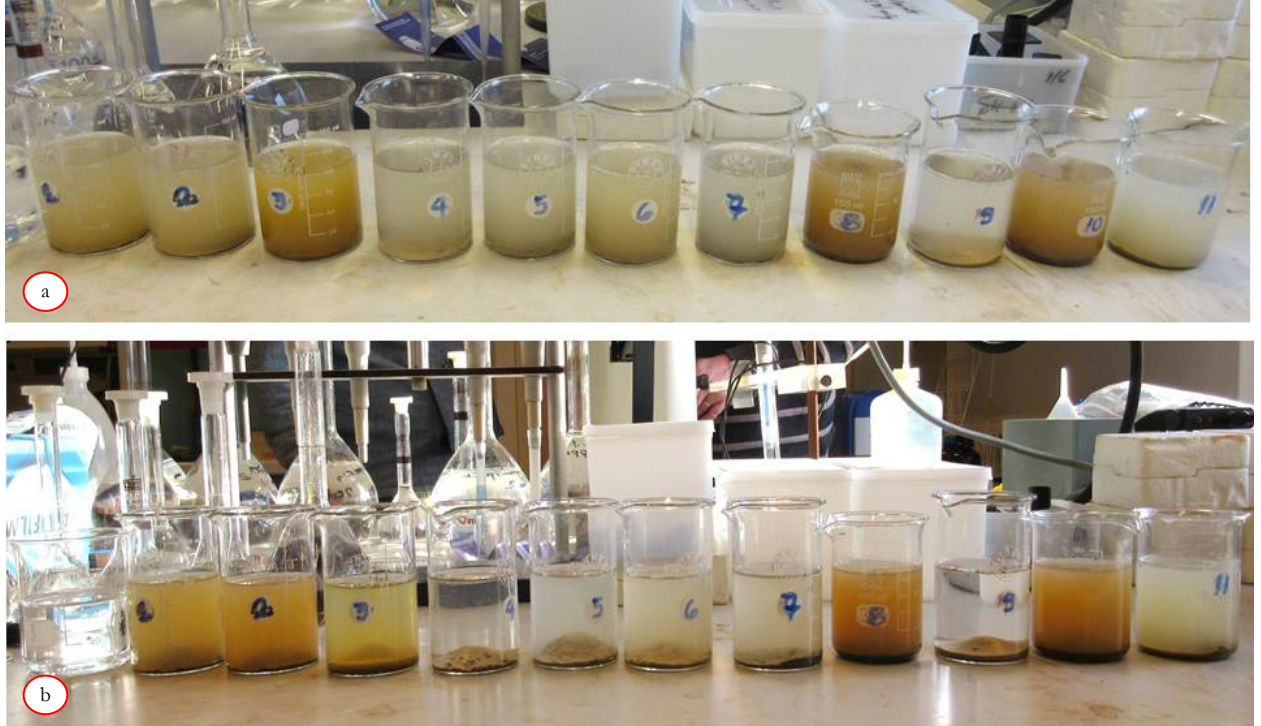
Figure 3. The set-up for the water extractable salts experiment. (a) Solution after stirring and (b) after being left overnight to settle (photos by de Smeth, 2015)

Ten (10) grams of sample (about 2.5 mL) was soaked in 97.5 mL de-ionized water in 100 mL beakers, stirred regularly and were left to stand overnight. The next morning, 10 ml of solution was decanted, centrifuged and analysed by Inductively Coupled Plasma Optical Emission Spectrometer (ICP-OES - Varian Liberty II Model). Ten (10) mL of HCl (1:3 diluted) was added to the remaining 90 mL, stirred regularly then left to settle overnight after which 10 mL was analyzed by ICP-OES for Ca and Fe.

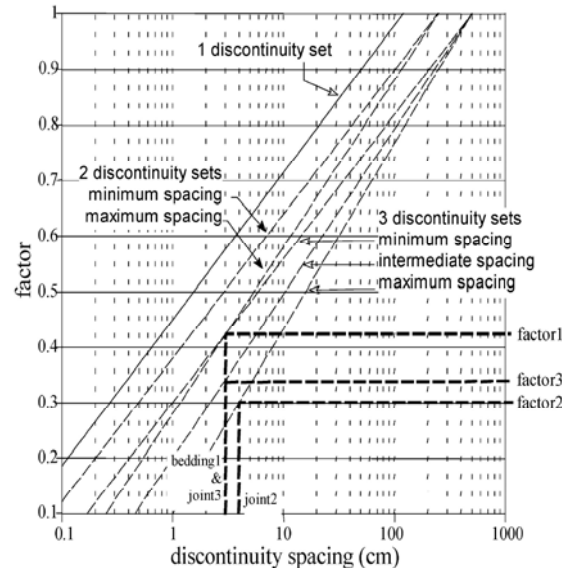
Figure 4. Discontinuity spacing factors (from Taylor (1980) in Hack (1998))

where SPA is the spacing parameter and the factors are obtained from Figure 4.

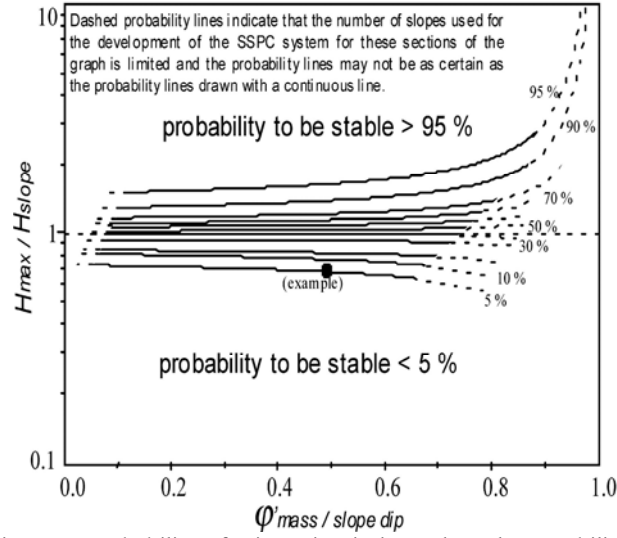
Figure 6. Probability of orientation independent slope stability. Percentage values indicate the probability of the slope to be stable (from Hack, 1998)

The ratio of the computed Hmax and the Hslope (Hmax/Hslope) and the ratio of the SFRI and the slope dip angle (SFRI/slope dip) are used to determine the probability to be stable for orientation independent stability using Figure 6. If SFRI > slope dip, the probability of the slope to be stable is 100%.

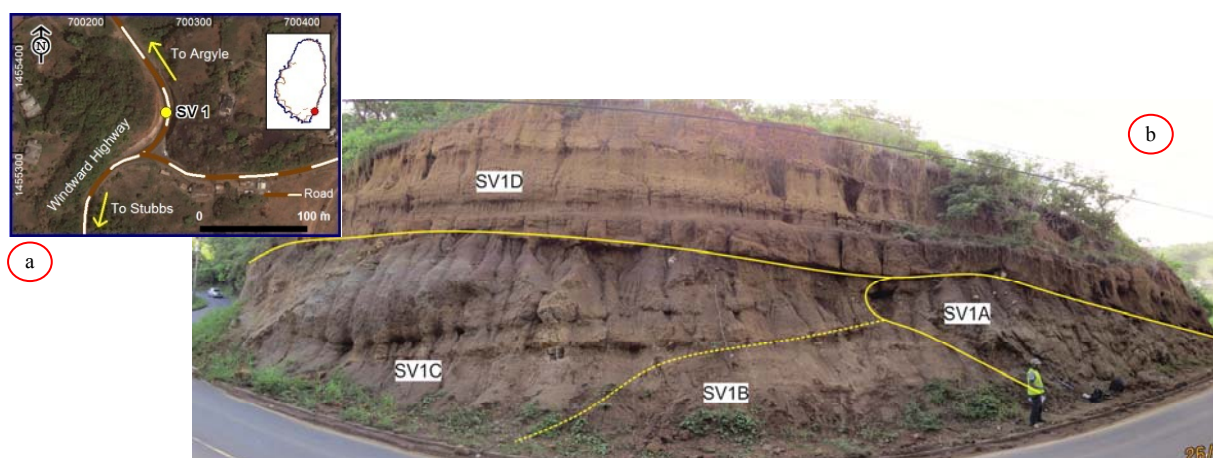
Figure 7. Exposure SV1 along the Windward Highway in Saint Vincent. (a) Location indicated by yellow dot in small map and general location shown by red dot in inset map; (b) Four geotechnical units are identified in the exposure. Map projection: UTM Zone 20 N, datum: WGS84, source: Google Earth. (photo by XAC, 2014)

Exposure SV1 is along the Windward Highway in the vicinity of the new airport in Argyle. The total size of the exposure is 60 m length with a maximum height of about 9 m. Based on the geologic map (Figure 42 in Appendix 10.1), this area is underlain by the "lava flows, domes and associated deposits" rock group. Four geotechnical units (GUs) are identified in this exposure (Figure 7b).

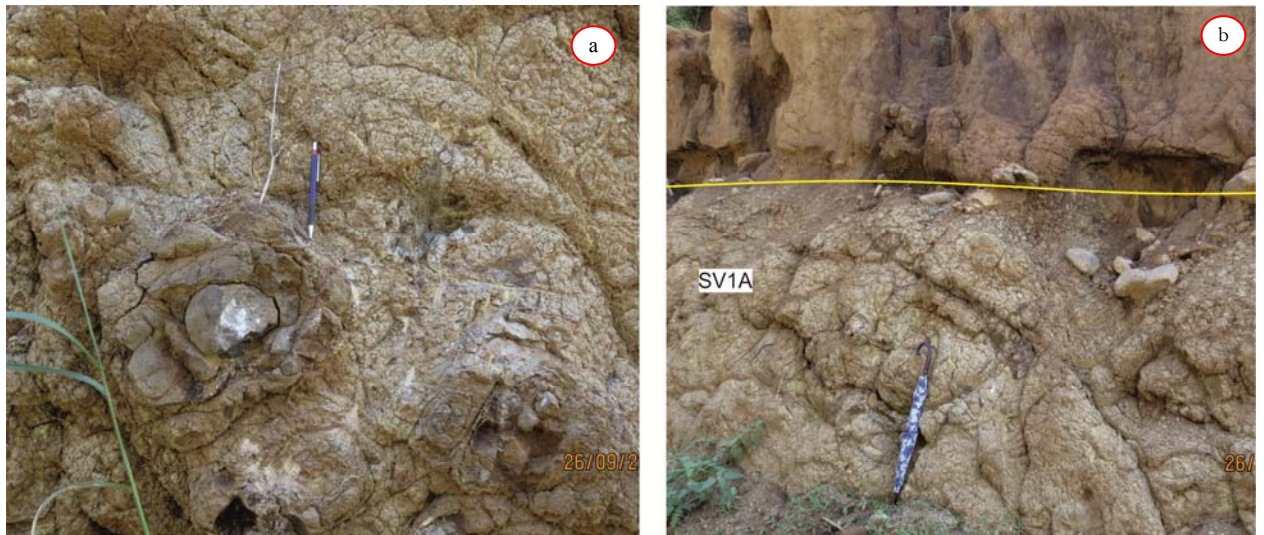
Figure 8. Highly weathered basalt in GU SV1A. (a) greenish-grey, vesiculated cores stones; (b) most joints are abutting in the contact with the overlying unit. (photos by XAC, 2014)

GU SV1A is a moderately weak (intact rock strength (IRS) = 8.75 MPa) greenish-light grey basalt lava, with inclusions of fresh, strong (IRS = 175 MPa) greenish dark-grey, vesiculated, coarse-grained core stones (Figure 8a). It is highly weathered. Three major discontinuity sets were observed: J1 – 60/050 with discontinuity spacing (DS) of 0.4 m, persistent within the unit, large-scale roughness slightly curved, small-scale roughness smooth undulating, with clay infill material, dry; J2 – 66/068 has DS of 0.3 m, terminating against the contact with the overlying unit (Figure 8b), slightly curved, smooth undulating, filled with clay material, dry; J3 – 8/080 has DS of 0.9 m, terminating against other discontinuities, curved, polished stepped, with clay infill material. No seepage observed and all discontinuities are dry.

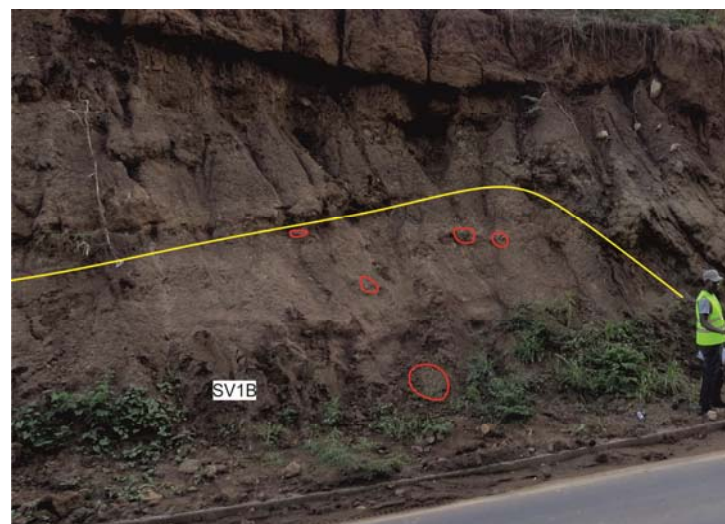
Figure 9. Highly weathered pyroclastic flow deposit in GU SV1B. Yellow line is the contact with the overlying unit and red circles outline the clasts. (photo by XAC, 2014)

GU SV1B is a tuff breccia deposit. The matrix is moderately weak ($IRS = 8.75 \text{ MPa}$), yellowish-brown tuffaceous material containing very few strong, light-grey, coarse grained andesite clasts. It is highly weathered as shown in Figure 9. There are three major discontinuity sets: J1 - 60/050 with DS of 0.12 m and terminating within the unit, slightly curved, polished undulating, filled with clay. J2 - 85/174 has DS of 0.02 m, abuts against the contact with the overlying unit, slightly curved rough undulating and filled with soft sheared fine material. J3 - 39/286 with DS of 2 m, terminating outside the unit, slightly curved, rough planar with only staining in walls. The surface material is very friable.

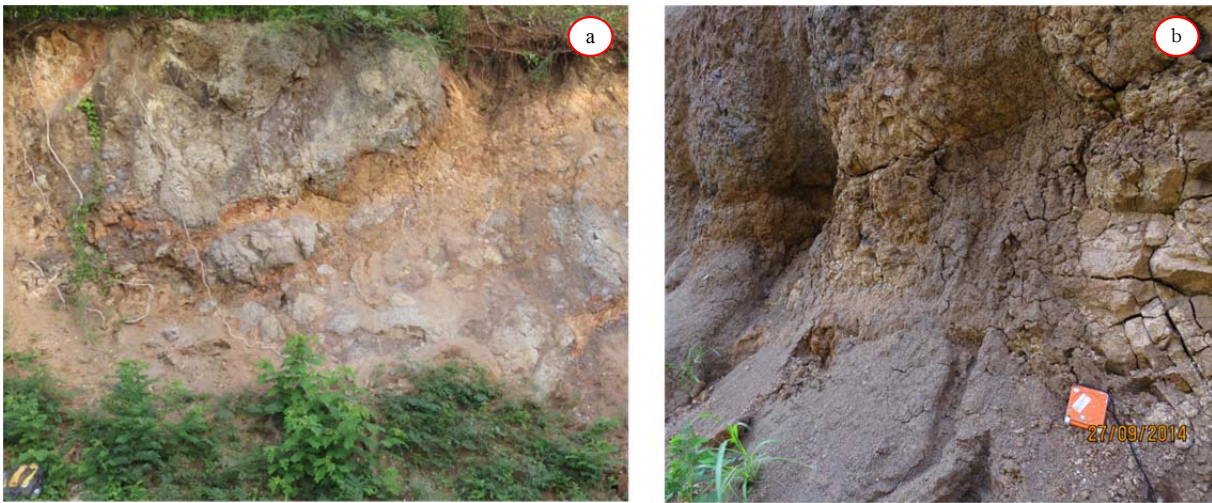
Figure 10. Block-and-ash flow (BAF) deposits in GU SV1C. (a) the clasts are cobbles and boulders of andesite; (b) highly friable surface of boulder-sized tuff clast (photos by XAC, 2014)

GU SV1C is a block-and-ash flow (BAF) deposit with clasts of boulders and cobbles of andesite (Figure 10a), as well as blocks of tuff (Figure 10b). These are imbedded in a weak (IRS = 3.125 MPa) orange-brown to buff, medium to fine-grained tuff matrix. Both clasts and matrix have very friable surfaces (Figure 5b) probably due to baking and chilling. There are three major discontinuity sets: J1 - 80/126, DS is 1.6 m, terminating within the unit, slightly curved, rough undulating, infilled with coarse soil. J2 - 80/204 has DS of 1.5 m, terminating within the unit, slightly curved, rough undulating. J3 - 30/314 with DS of 0.1 m, terminating against discontinuities, curved rough, undulating with clay infills. J4 - 10/070 with DS of 0.02 m, terminating against other discontinuities, slightly curved, smooth undulating with clay infill material. All the discontinuities are dry.

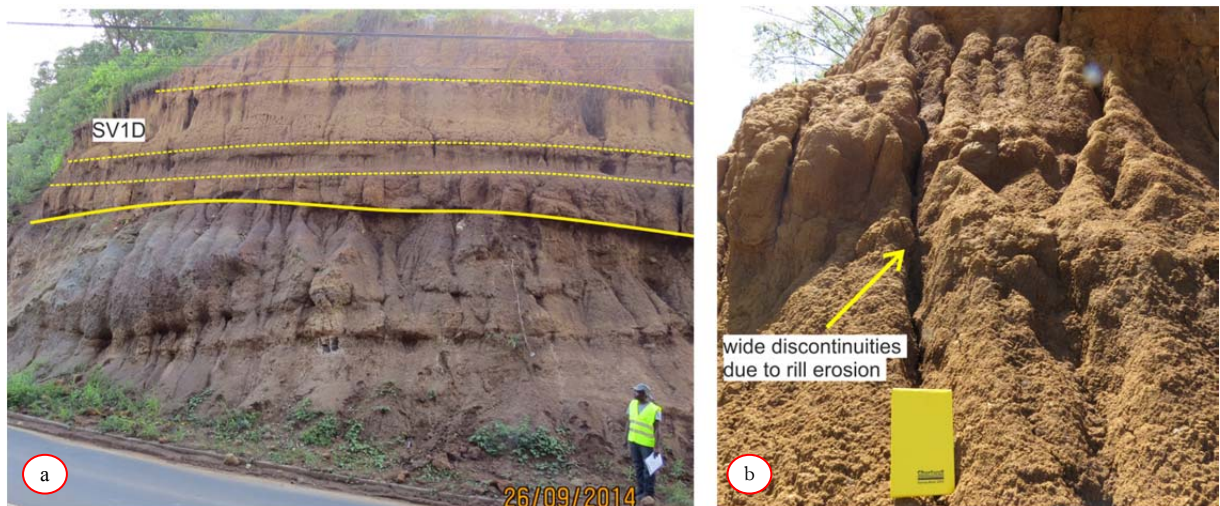
Figure 11. Tuff overlying the other GUs in GU SV1D. (a) layers separated by weathering horizons shown in dashed yellow lines; (b) some discontinuities appear to be widened or caused by rill erosion. (photos by XAC, 2014)

GU SV1D overlies all the three units previously described. It is a very weak, thinly, (top of exposure) to thickly (edge of exposure) bedded, brown, tuff. It is generally highly weathered and friable. Four layers are separated by dark brown weathering horizons shown in dashed yellow lines in Figure 11a. Three discontinuity sets are recorded: Bedding plane - 39/286 DS of 0.2 to 1 m, persistent throughout the exposure; J1 - 80/223 has DS of 0.5 m, terminating within the unit and against other discontinuities, straight, rough planar with clay infills. J2 - 90/296, DS is 0.5 m, terminating against other discontinuities, including the contact with the other layers, curved, rough planar, infilled with clay. Some joints appear to be widened or caused by rill erosion (in yellow arrow in Figure 11b).

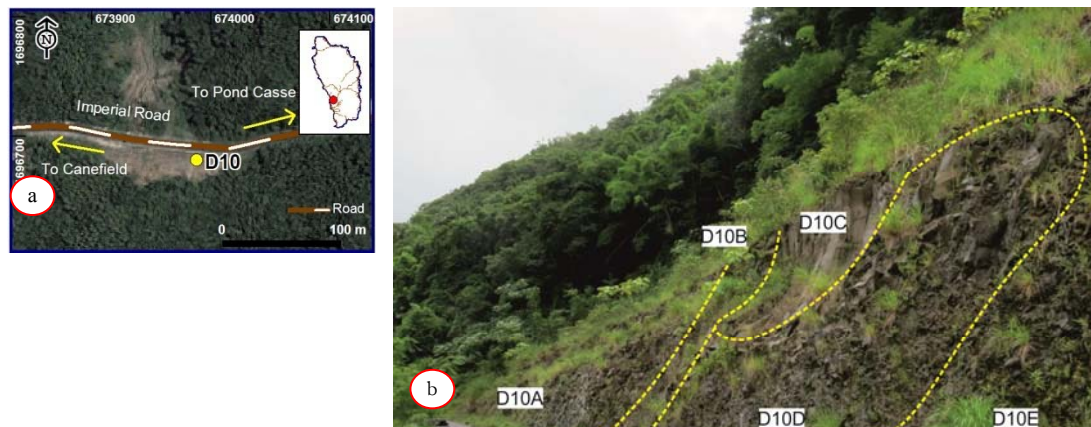
Figure 12. Exposure D10 . (a) location of the exposure along the Imperial Road; (b) Five geotechnical units based discontinuity pattern and rock mass weathering. Map projection: UTM Zone 20 N, datum: WGS84, source: Google Earth. (photos by XAC, 2014)

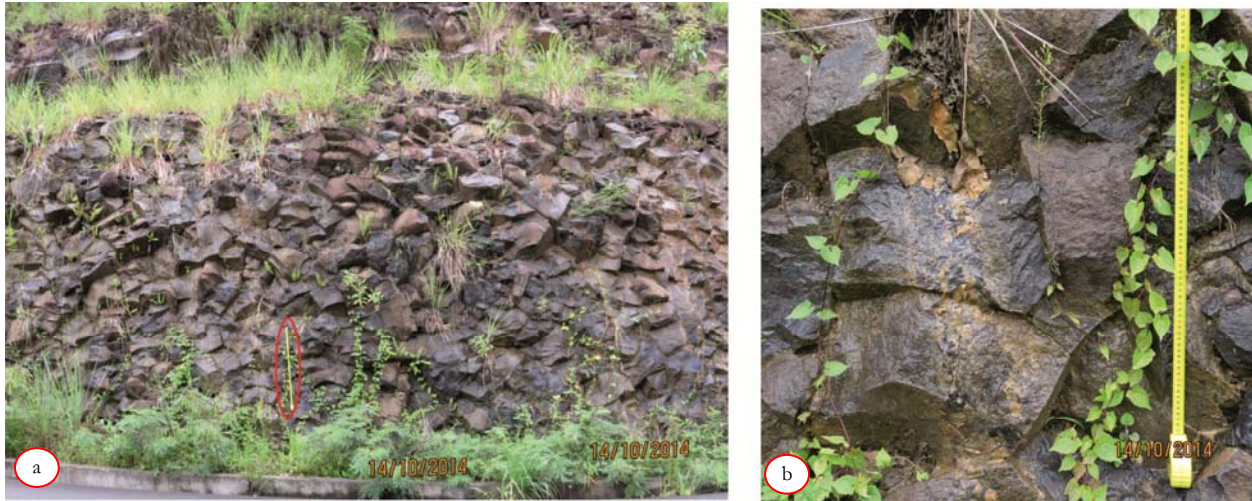
Figure 13. Discontinuities in GU D1A. (a) the discontinuities for polyhedral blocks (1 m tape in red circle) ; (b) amorphous deposits on the surface of discontinuities indicate trace of water flow path. (photos by XAC, 2014)

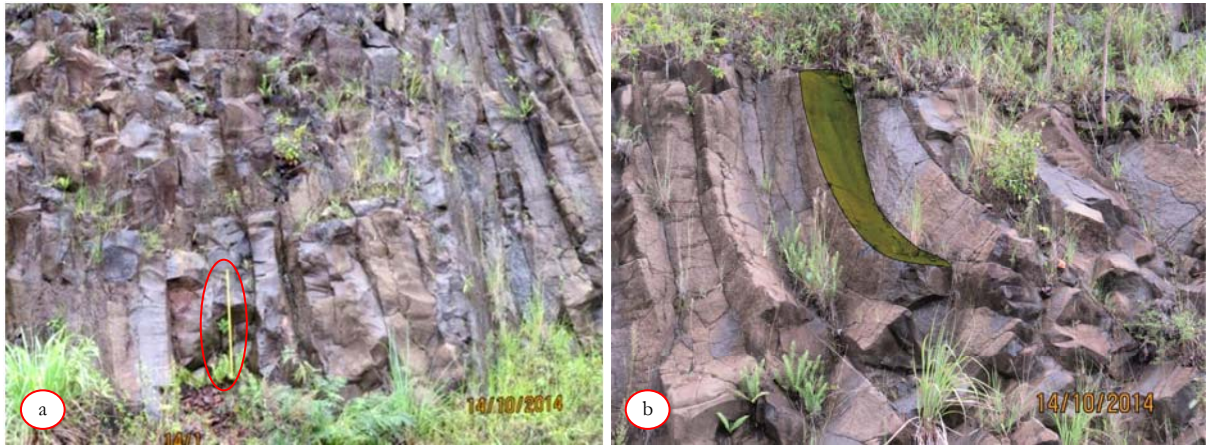
Figure 14. Columnar blocks formed by the discontinuity sets (a) in GU D10B (yellow tape in red circle is 1 meter) and (b) curved discontinuities (in yellow plane) in GU D10C

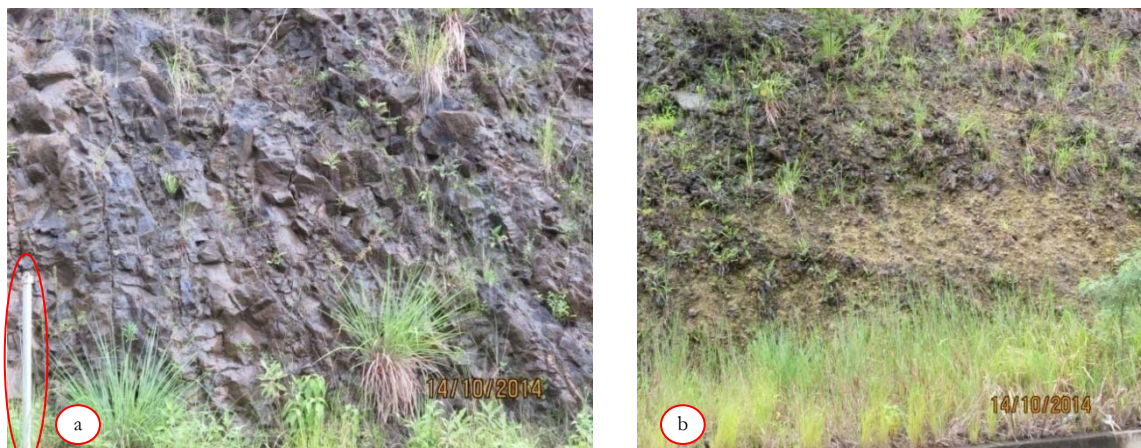
Figure 15. Smaller blocks formed by discontinuities in GUs D10D and D10E. (a) the rock mass in GU is moderately weathered in GU D10D and (b) highly weathered in GU D10E. (photos by XAC, 2014)

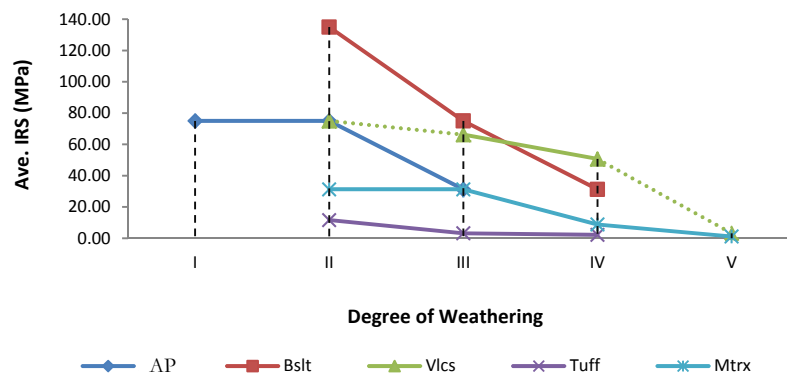
Figure 16. Average Intact Rock Strength (Ave. IRS) vs. degree of weathering. The IRS generally decreases with increasing degree of weathering. (Markers indicate average values from multiple GUs; the lines between the markers have no meaning, these are for identification and indication of data uncertainty only: solid lines indicate low uncertainty and dotted lines indicate high uncertainty. Refer to Table 5 for the explanation of the abbreviation and notations).

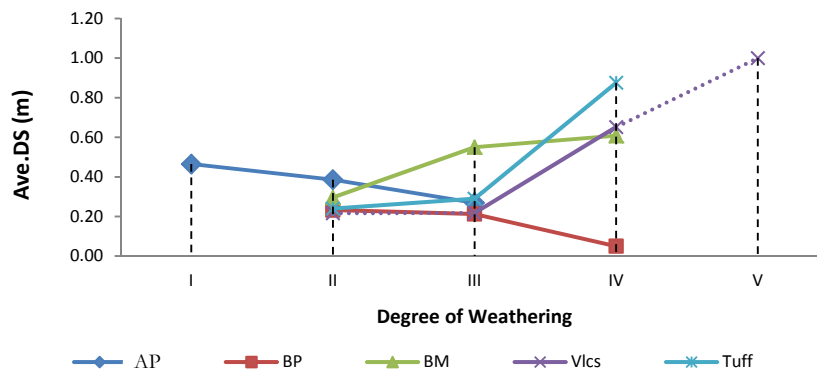
Figure 17. Average discontinuity spacing (Ave. DS) vs. degree of weathering. The Ave. DS is decreasing with increasing degree of weathering for AP and BP GUs and generally increasing with increasing degree of weathering in the BM, Vlcs and Tuff GUs. (Markers indicate average values from multiple GUs; the lines between the markers have no meaning, these are for identification and indication of data uncertainty only: solid lines indicate low uncertainty and dotted lines indicate high uncertainty. Refer to Table 5 for the explanation of the abbreviation and notations).

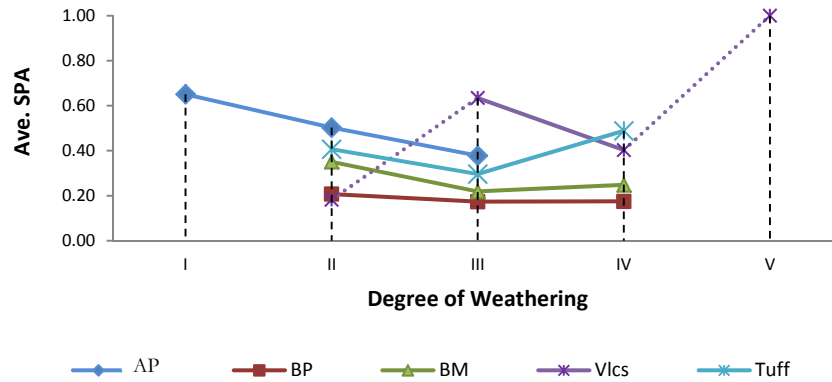
Figure 18. Average SPA (Ave. SPA) vs. degree of weathering. The Ave. SPA is generally decreasing from fresh to moderately weathered GUs of most of the rock types and generally increasing from moderately weathered to completely weathered BM and Tuff GUs (with the exception of the slightly weathered Vlcs GU). (Markers indicate average values from multiple GUs; the lines between the markers have no meaning, these are for identification and indication of data uncertainty only: solid lines indicate low uncertainty and dotted lines indicate high uncertainty. Refer to Table 5 for the explanation of the abbreviation and notations).

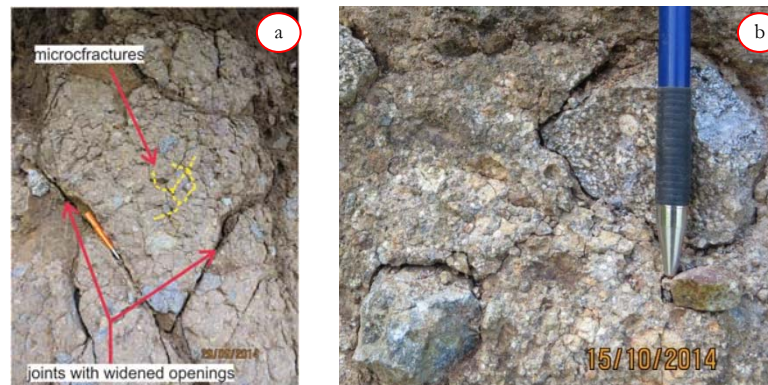
Figure 19. Apertures of discontinuities in highly weathered rocks. (a) Discontinuities become more visible in tuff breccia when the discontinuity aperture increases as result of increasing degree of weathering ;(b) increased opening along the matrix-clast interface in the Vlcs (photos by XAC, 2014, Saint Vincent (a); Dominica (b))

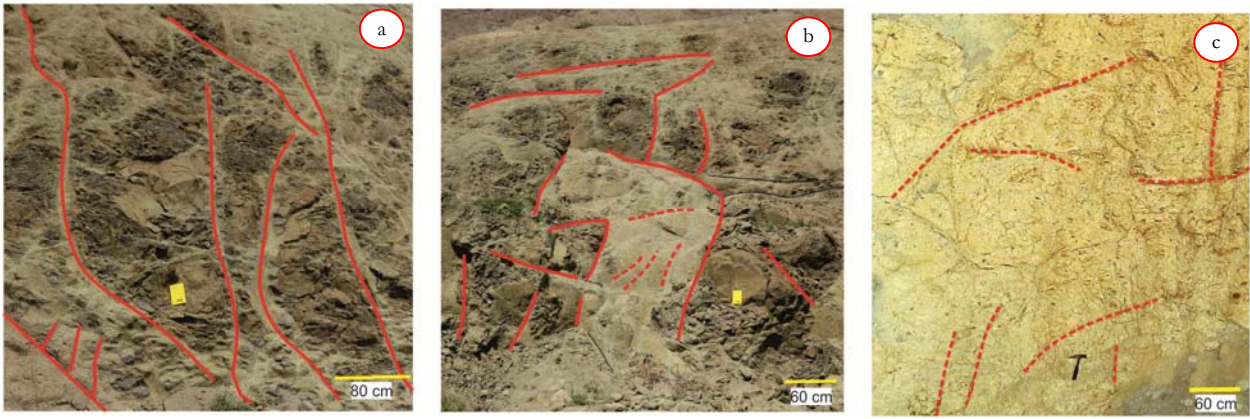
Figure 20. Joints becoming less evident with increasing degree of weathering. (a) persistent cooling joints in moderately weathered BM GU; (b) widened distance between joints with increasing weathering of core stones; (c) faint traces of joints in highly weathered BM GU (photos by XAC, 2014; SV2, Saint Vincent)

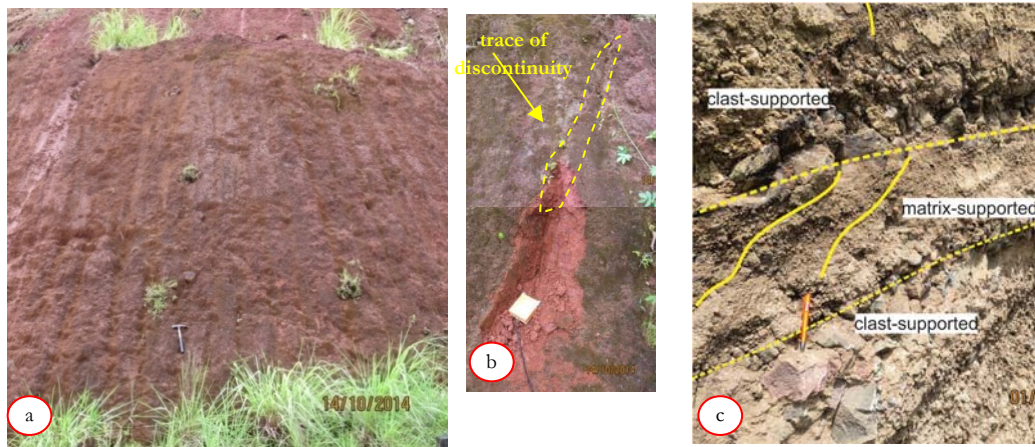
Figure 21. Discontinuities in completely weathered exposure and highly weathered Vlcs GUs (a) Apparently massive rock mass (b) very faint surface manifestation of a persistent discontinuity; (c) Discontinuities in clast-supported and matrix-supported tuff breccia. Fewer joints in the clast supported highly weathered tuff breccia (SV7A) suggesting that spaces between the clasts are enough to accommodate internal stresses caused by weathering. (photos by XAC, 2014; a, b: Dominica; c: Saint Vincent)

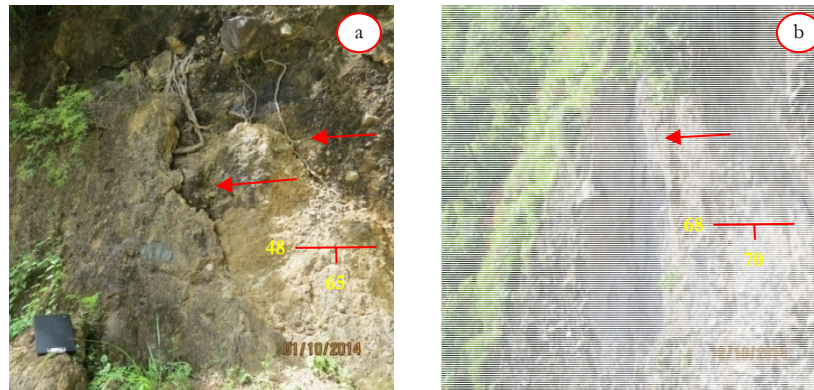
Figure 22. Unloading joints resulting from combined weathering and stress relief. (a) Joints parallel to sub-parallel to the slope correspond to unloading joints seen in block-and-ash flow deposits in SV8, Saint Vincent and (b) in lahar deposits in D7, Dominica. (red lines point to strike of joint planes) (photos by XAC, 2014)

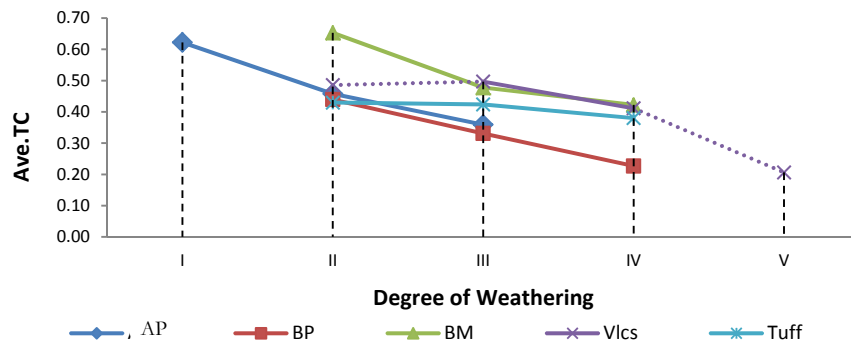
Figure 23. Average TC (Ave. TC) vs. degree of weathering. The average TC values in all rock types are consistently decreasing with increasing weathering degree. (Markers indicate average values from multiple GUs; the lines between the markers have no meaning, these are for identification and indication of data uncertainty only: solid lines indicate low uncertainty and dotted lines indicate high uncertainty. Refer to Table 5 for the explanation of the abbreviation and notations).

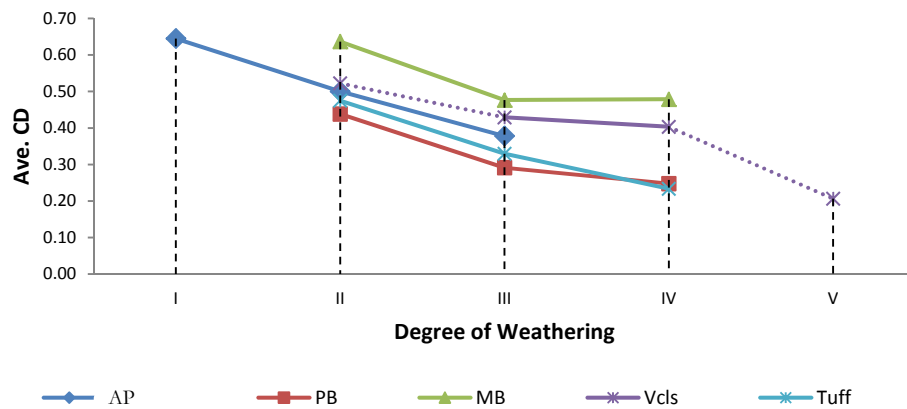
Figure 24. Average CD (Ave. CD) vs. degree of weathering. The average CD values in all rock types are decreasing with increasing degree of weathering. (Markers indicate average values from multiple GUs; the lines between the markers have no meaning, these are for identification and indication of data uncertainty only: solid lines indicate low uncertainty and dotted lines indicate high uncertainty. Refer to Table 5 for the explanation of the abbreviation and notations).

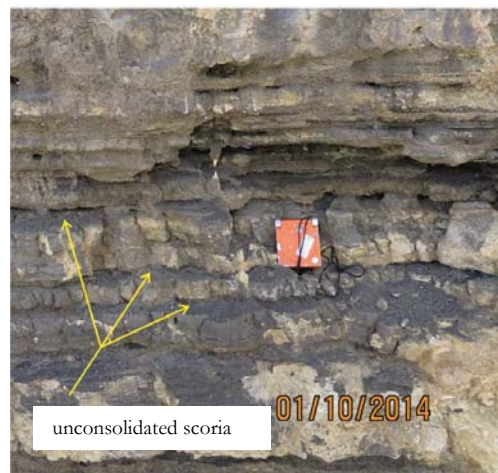
Figure 25. "Flowing" Im in tuff beds. The unconsolidated scoria in between tuff beds in SV5, Saint Vincent is classified as flowing infill materials that gives a very low Im value in the SSPC system (photo by XAC, 2014)

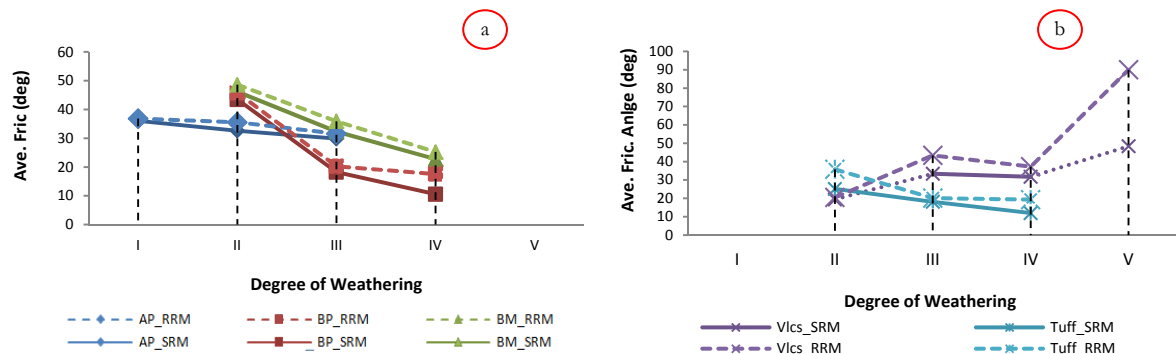
Figure 26. Average Friction Angle (Ave vs. degree of weathering. (a) The difference in the average values of SRM (solid and dotted lines) and RRM (dashed lines) represents the effect of weathering in the AP, BP and BM; (b) and in the Vlcs and Tuff. (Markers indicate average values from multiple GUs; the lines between the markers have no meaning, these are for identification and indication of data uncertainty only: solid lines indicate low uncertainty and dotted lines indicate high uncertainty. Refer to Table 5 for the explanation of the abbreviation and notations).

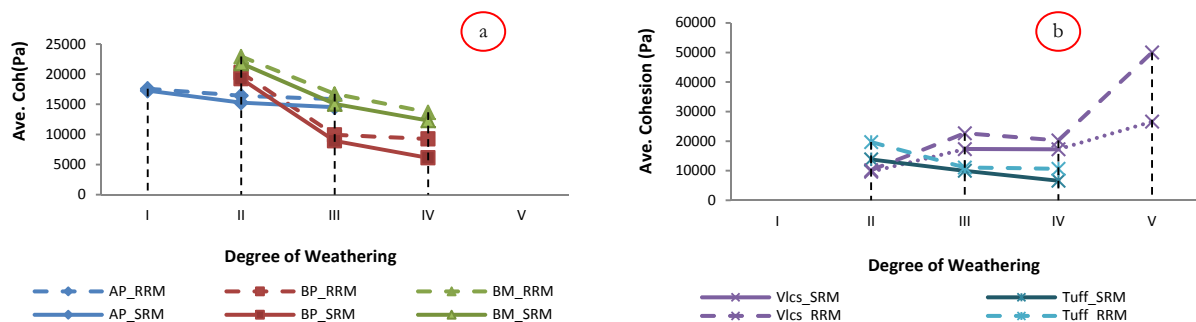
Figure 27. Average Cohesion (Ave. Cohesion) vs. degree of weathering. (a) the difference in the average values of SRM (solid and dotted lines) and RRM (dashed lines) values represents the effect of weathering in the AP, BP and BM (b) in the Vlcs and Tuff. (Markers indicate average values from multiple GUs; the lines between the markers have no meaning, these are for identification and indication of data uncertainty only: solid lines indicate low uncertainty and dotted lines indicate high uncertainty. Refer to Table 5 for the explanation of the abbreviation and notations).

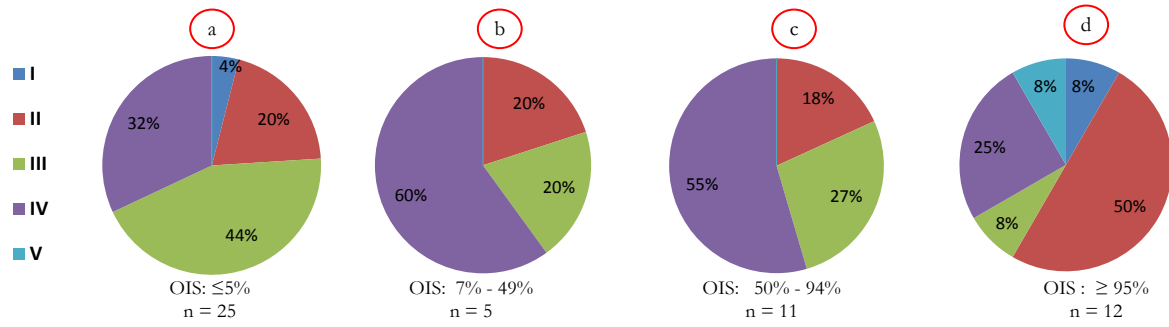
Figure 28. Degree of weathering of the GUs in the OIS stability classes. The class with $\leq 5\%$ probability to be stable are dominantly moderately weathered whereas the classes with $\geq 95\%$ probability are slightly weathered. Highly weathered GUs are dominant in the classes with 7%-49% and 50%-94% probability of stability.

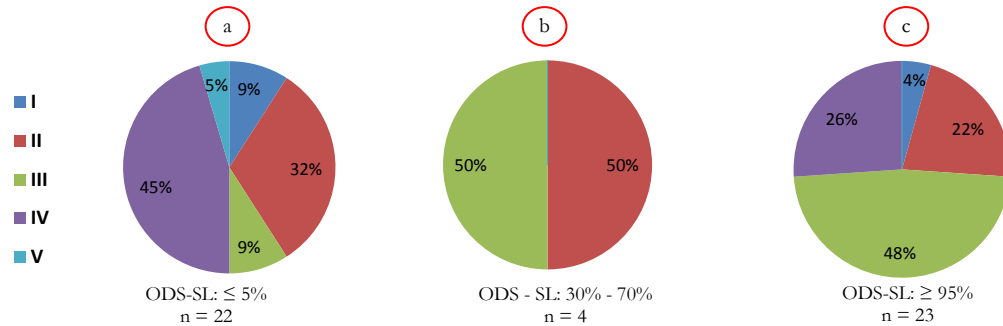
Figure 29. Degree of weathering of GUs in the ODS-sliding criterion classes. Highly weathered GUs are dominant in the class with $\leq 5\%$ probability to be stable whereas moderately weathered GUs are dominant in the class with $\geq 95\%$ probability to be stable

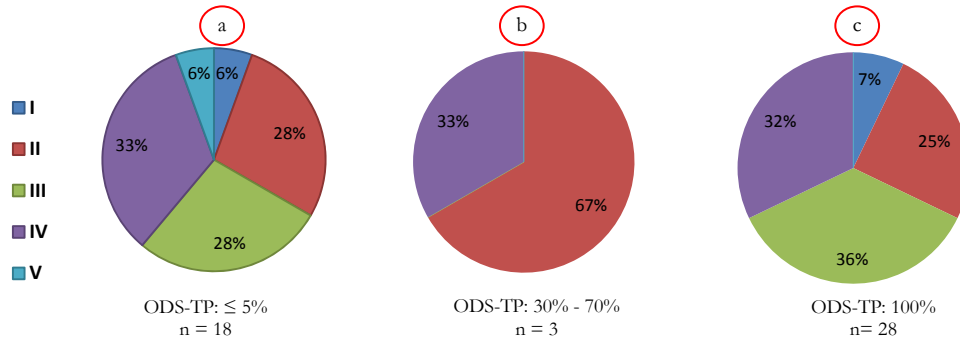
Figure 30. Degree of weathering of GUs in the ODS-toppling criterion classes. The the slightly weathered to highly weathered GUs are almost uniformly distributed in the $\leq 5\%$ and $\geq 95\%$ probability classes of stability. Slightly weathered GUs are also more dominant in the 30% - 70% probability of stability class

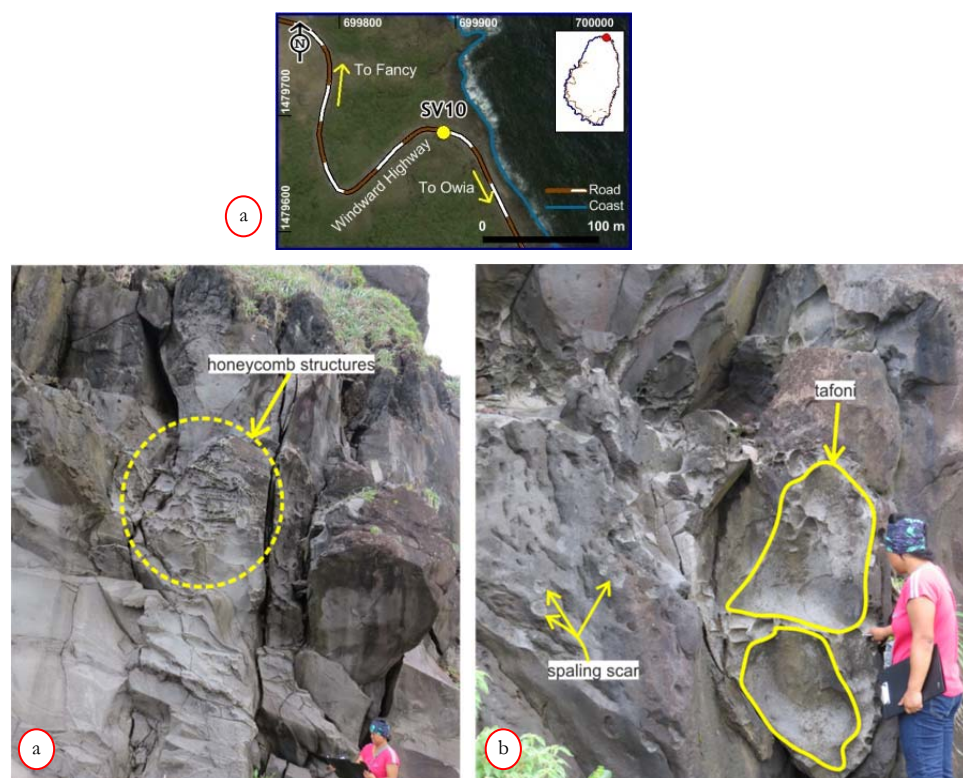
Figure 31. Indicators of salt weathering in Exposure SV10. (a) location of the exposure; (b) honeycomb structures; (c) tafoni and scars from spalling. Map projection: UTM Zone 20 N, datum: WGS84, source: Google Earth (photos by XAC,2014)

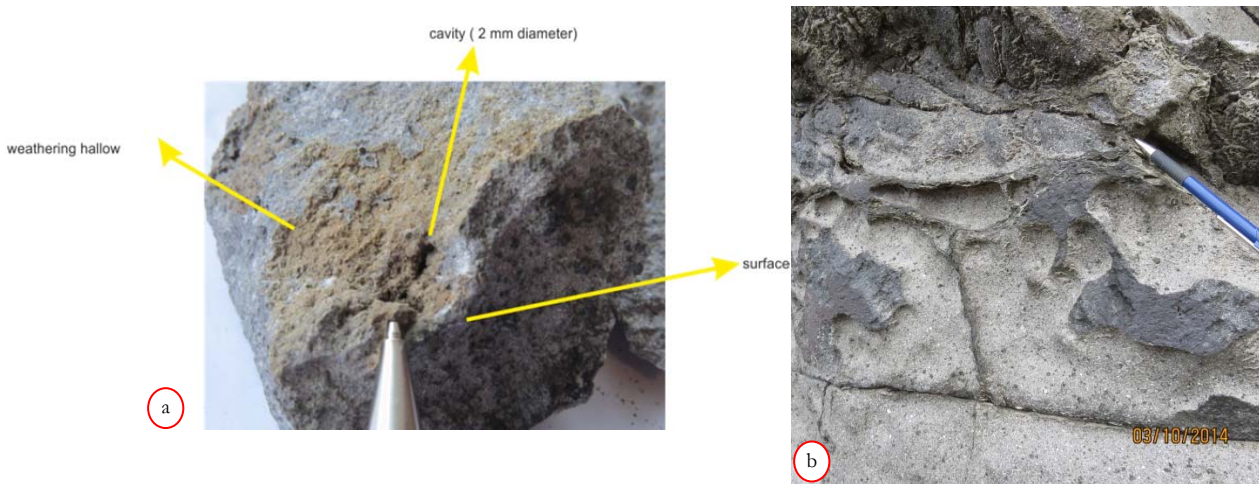
Figure 32. Cavities probably caused by salt weathering in the andesites. (a) chipped off fragment from the exposure reveal cavities that are surrounded by brown discoloration that is not visible in the original surface. (scale: tip of pen at centre bottom, diameter about 1 mm). (b) closer view of the cavities forming the honeycomb structures that could have resulted from the cavities shown in b. Map projection: UTM Zone 20 N, datum: WGS84, source: Google Earth (photos by XAC,2014; Saint Vincent)

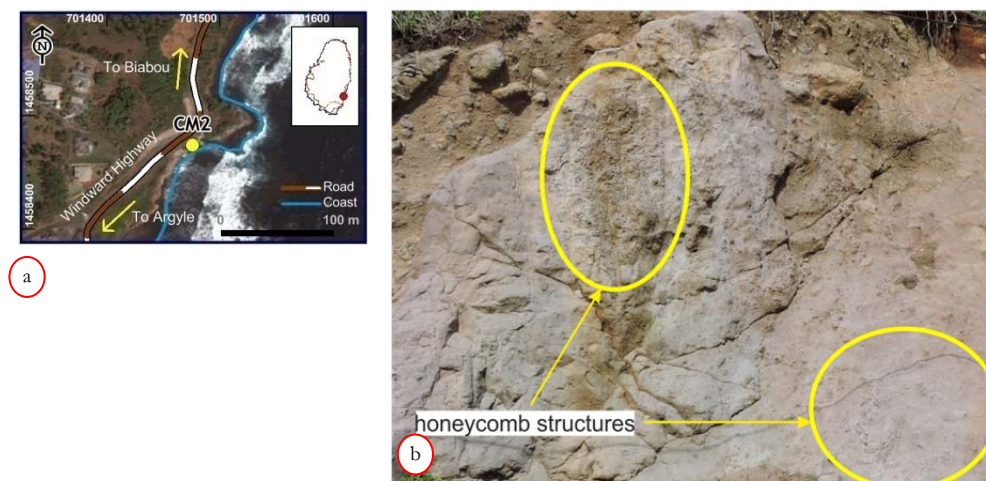
Figure 33. Honeycomb structures in exposure CM2. (a) Exposure CM2 indicated by black arrow in inset map of island; (b) poorly developed but still visible honeycomb structures; Map projection: UTM Zone 20 N, datum: WGS84, source: Google Earth (*photo direction 340° from the yellow dot on the map; by CM; 2014; note: exposure investigated by CM, used only by this author to show salt weathering influence; not included in the investigation of rock properties*)

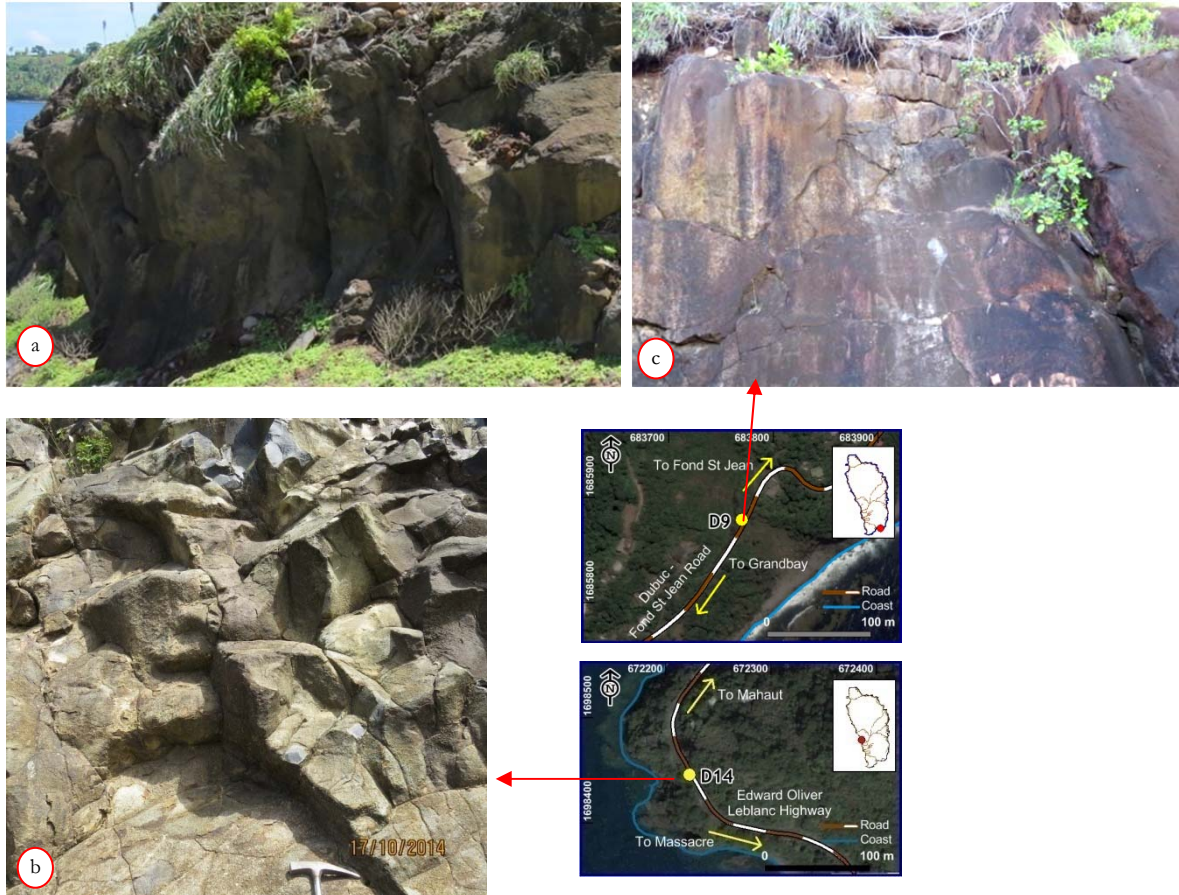
Figure 34. Examples of lava flow exposures in Saint Vincent and Dominica that do not exhibit visible indications of salt weathering (a) GU SV10A in the exposure SV10 with slope not directly facing the Atlantic Ocean; (b) andesite pillows in exposure D14 in Dominica. Map projection: UTM Zone 20 N, datum: WGS84, source: Google Earth *photo direction 050° from the yellow dot position*; (c) basalt in exposure D14 in Dominica. (*photo direction 90° from the yellow dot position. photos by XAC, 2014*)

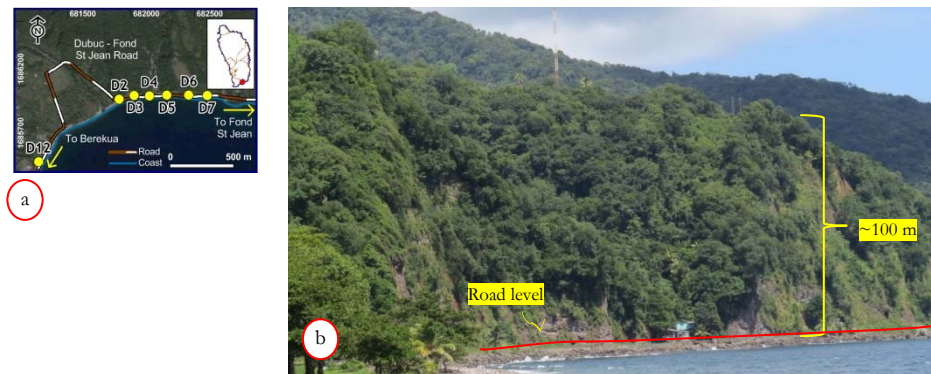
Figure 35. Exposures of lahar deposits in the southeastern side of Dominica (a) location of the lahar deposits (D2-D5) and ignimbrites exposures (D12); (b) coastal road in the area showing high cliffs and the road alignment very close to the sea (*from D12 in map, photo direction 040°, photo by XAC, 2014*) Map projection: UTM Zone 20 N, datum: WGS84, source: Google Earth

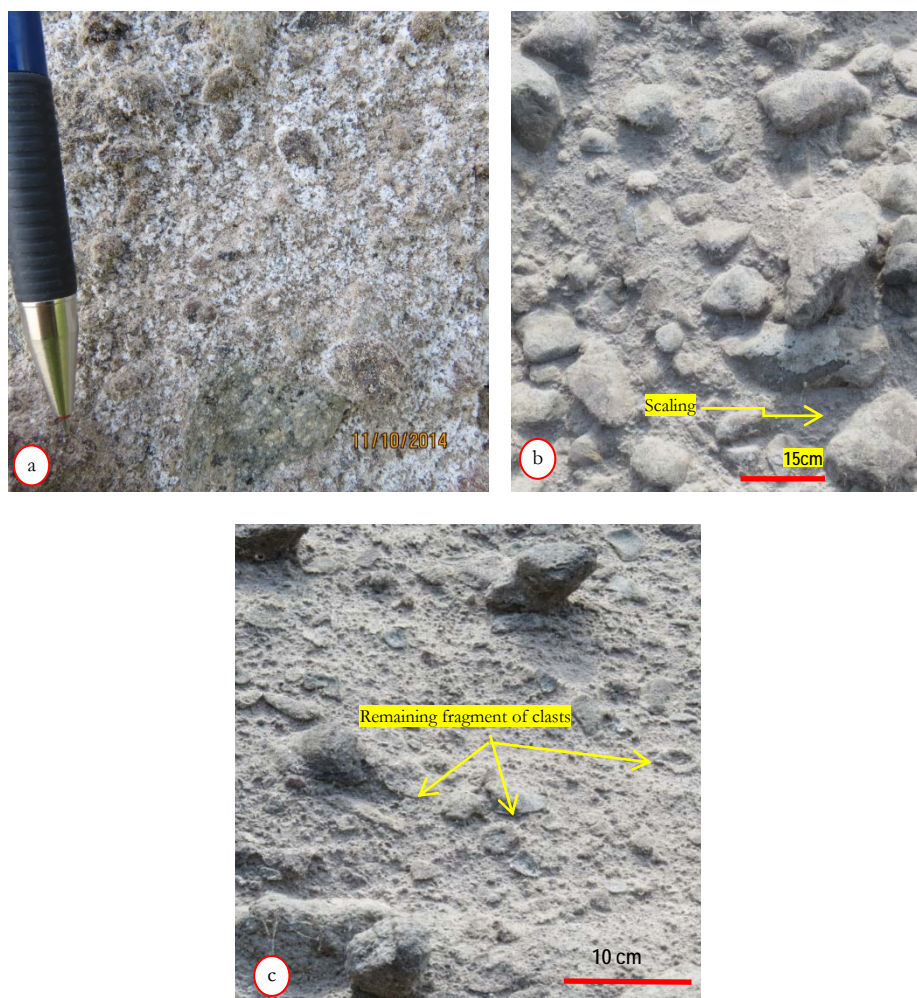
Figure 36. Indicators of salt weathering in the lahar deposits. (a) Salt crystals in the surface of the slope; (b) scaling in the andesite clasts; (c) fragments left by a dislodged clasts, the slope surface is generally covered by powdery material that probably correspond to rockmeals rock meals (photos by XAC, 2014)

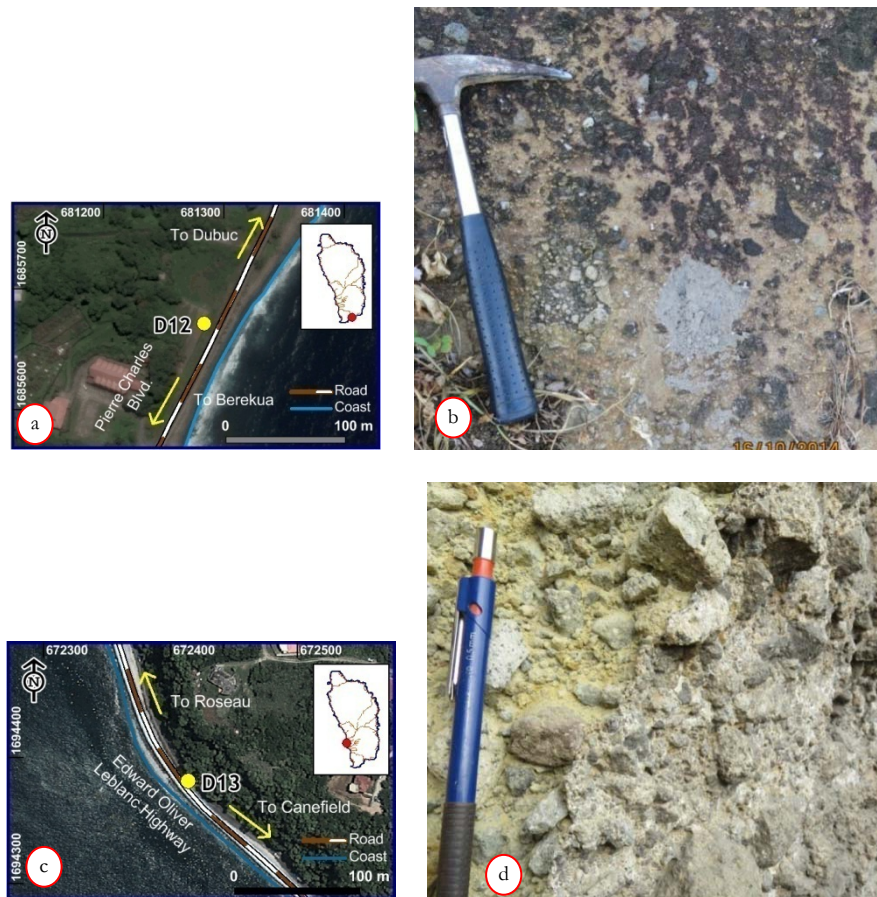
Figure 37. Hardened surfaces probably due to salt influence on the ignimbrite and BAF deposits (a) Location of exposure D12; (b) dark-grey coating and light-grey fresh surface of the ignimbrites in exposure D12; (c) location of exposure D13; (d) light-grey surface and poorly consolidated materials behind in the BAF deposits in exposure D13. Map projection: UTM Zone 20 N, datum: WGS84, source: Google Earth (photo XAC, 2014)
