EFFECTS OF WEATHERING IN THE ROCK AND ROCK MASS PROPERTIES AND THE INFLUENCE OF SALTS IN THE COASTAL ROADCUTS IN SAINT VINCENT AND DOMINICA

Thesis submitted to the Faculty of Geo-Information Science and Earth
Observation of the University of Twente in partial fulfilment of the
requirements for the degree of Master of Science in Geo-information Science
and Earth Observation.

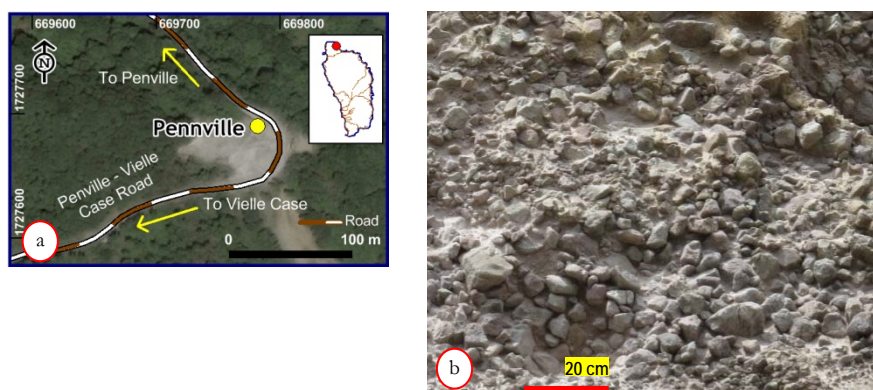
Figure 38. BAF exposure in a quarry in Pennville, Dominica (a) Location of the quarry. (b) The hard surface coating in exposure D13 is absent in the surface of the BAF exposure in this quarry (yellow dot on the map indicates camera position, photo direction looking 230°; photo, by XAC, 2014) Map projection: UTM Zone 20 N, datum: WGS84, source: Google Earth

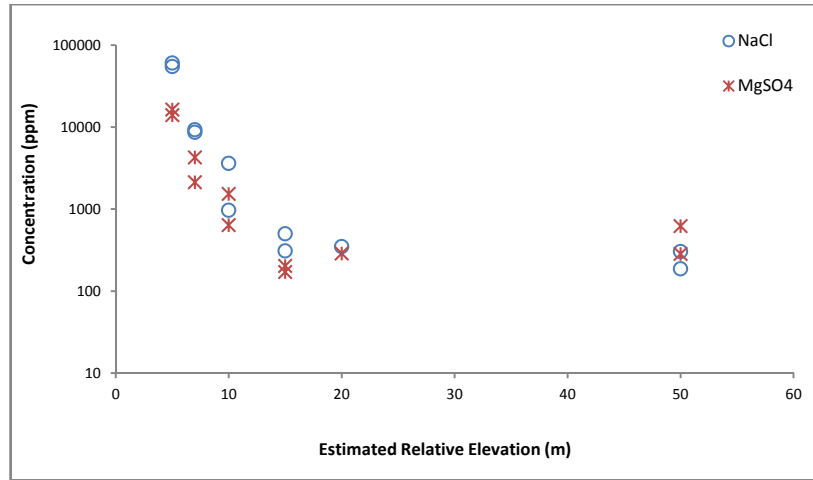
Figure 39. Estimated elevation (m) vs. salt concentration (ppm). The concentrations of NaCl and MgSO₄ are decreasing with increasing estimated relative elevation from msl

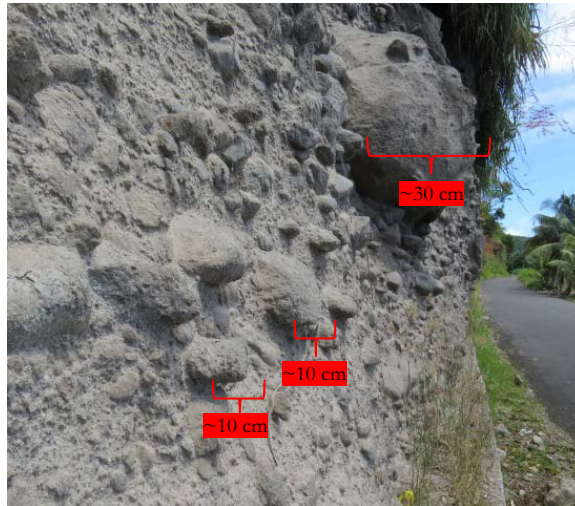
Figure 40. Estimating rate of salt weathering. The protrusion of clasts is used as estimate of the rate in the retreat of matrix that maybe attributed to the granular disintegration mechanism of salt weathering (*photo, XAC, 2014*)

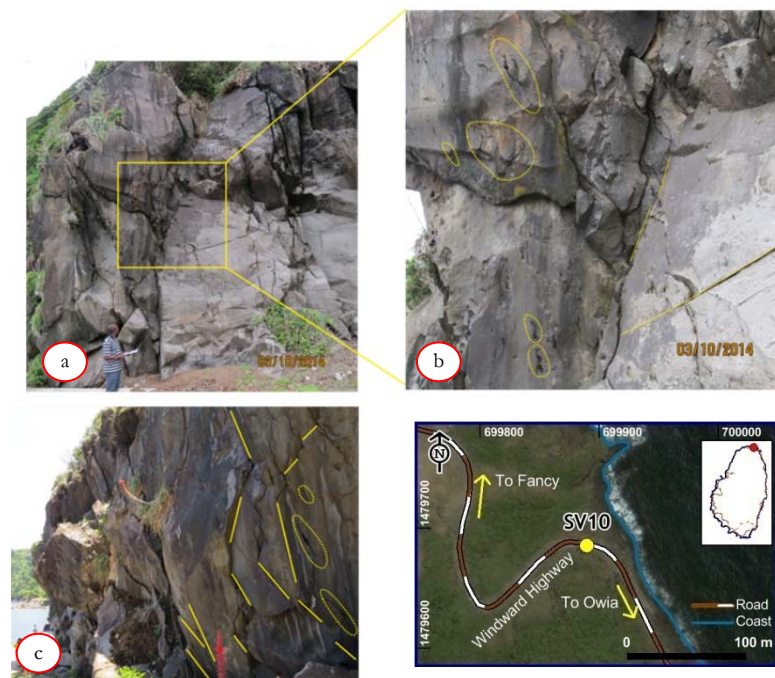
Figure 41. Incipient development of new discontinuity sets in Exposure SV10 due to salt weathering. (a) highly jointed part of the andesite exposure; (b) wavy and short discontinuities (in dotted outlines) appear to develop from interconnecting cavities (c) straight traces of cooling joints versus the developing discontinuities (solid lines). (Photos by XAC, 2014)
