IMPLEMENTATION OF THE MODEL SAFE SCHOOL PROGRAMME IN THE CARIBBEAN

HAZARD RISK ASSESSMENT REPORT AND COSTED ACTION PLAN

THE ADELE SCHOOL FOR SPECIAL CHILDREN

ANTIGUA AND BARBUDA

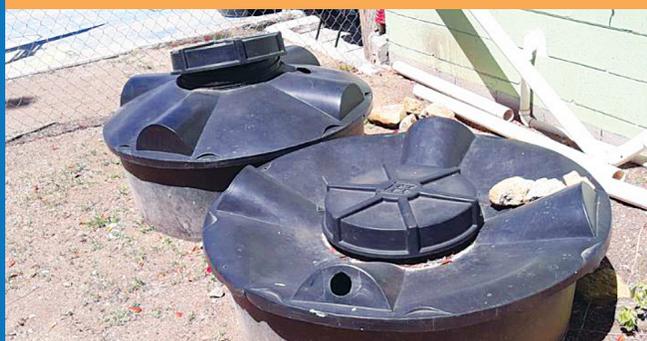
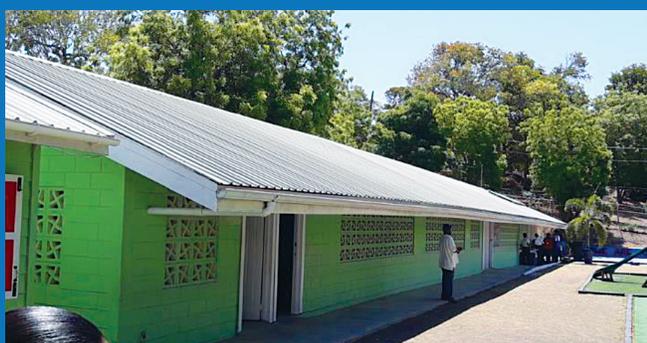
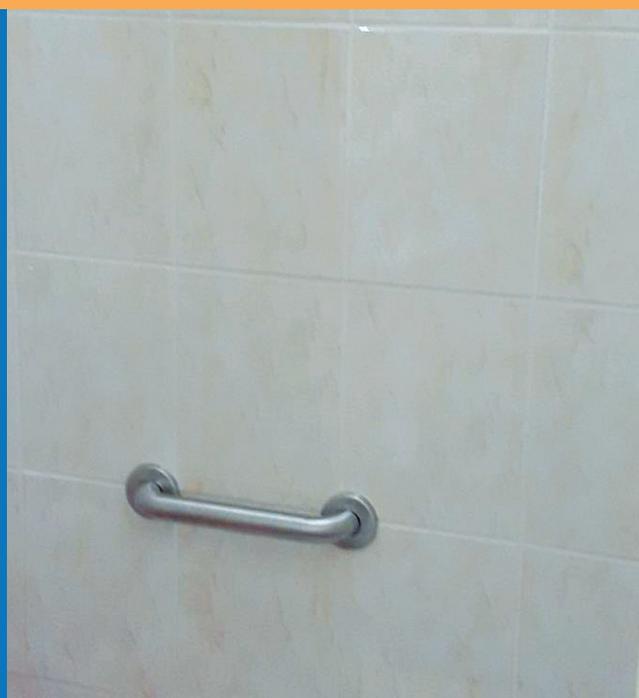
FIGURE 7.1: SOME EXAMPLES OF KEY STRENGTHS AT THE ADELE SCHOOL FOR SPECIAL CHILDREN (E.G. ADDITIONAL WATER STORAGE, WHEELCHAIR ACCESSIBLE CLASSROOMS, HAND RAILINGS IN BATHROOM, ETC.)

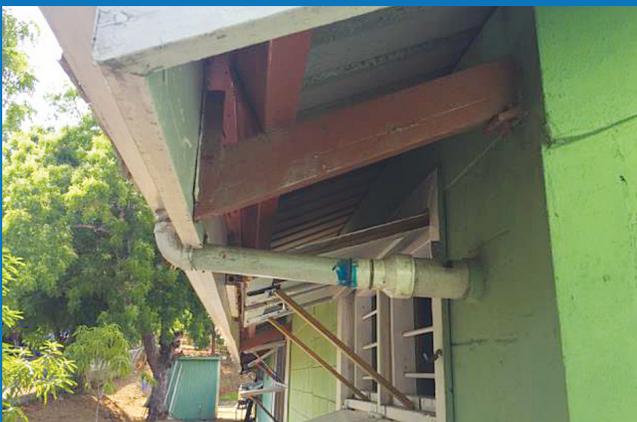
■ RAINWATER HARVESTING IN PRACTICE
