# HAZARD RISK ASSESSMENT REPORT AND COSTED ACTION PLAN

## ELLERSLIE SCHOOL

BARBADOS

Original Submission Date: November 12, 2019

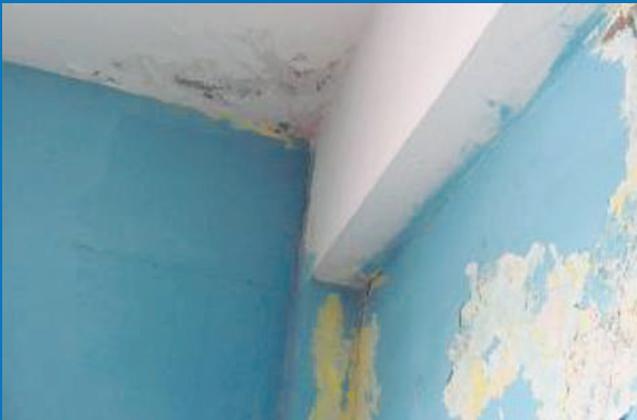
■ POSSIBLE SIGNS OF MOLD

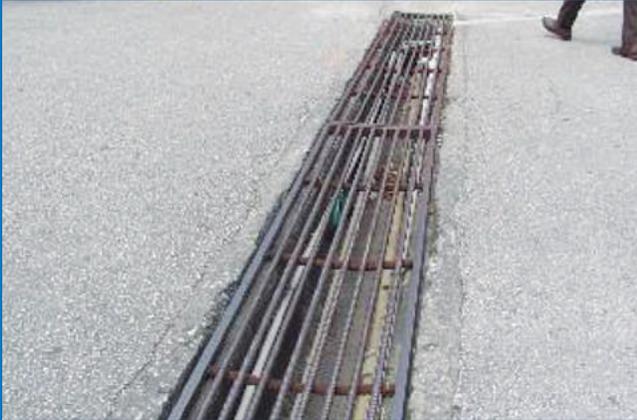
■ STORM WATER INTAKE APPEARS INADEQUATE
